# *CHFA* Capital Needs Assessment and Replacement Reserve Analysis

Harold J. Murphy Complex  
CHFA #89038D  
Rocky Hill Housing Authority  
Rocky Hill, CT

May 2, 2013

*Final Report*

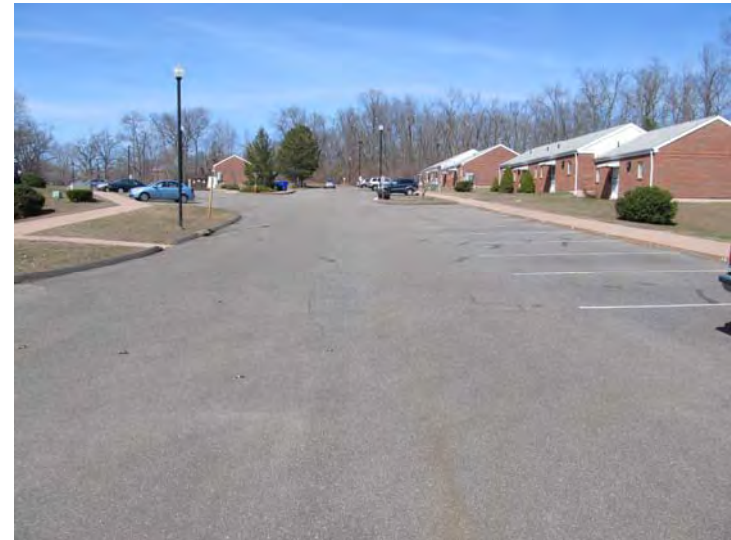
Asphalt-paved surfaces are in good condition for their age

- Original asphalt-paving is in good condition for its age; future resurfacing is shown in Year 7.
- Concrete sidewalk surfaces are in good condition; periodic future allowances are shown starting in Years 6.
- No cracks, mortar loss, or other damage was noted at exterior brick veneer wall surfaces; no near-term needs are anticipated.
- Common, unit, and service entry doors are currently in good condition; no near-term needs are anticipated. Replacement allowances for storm doors are shown initially in Years 2-4 and again in Years 17-19.
- The original casement-style windows reportedly pose operational difficulties for residents, and replacement in 2013 was being planned at the time of the site assessment; an allowance to complete this anticipated scope of work is shown in Year 1.

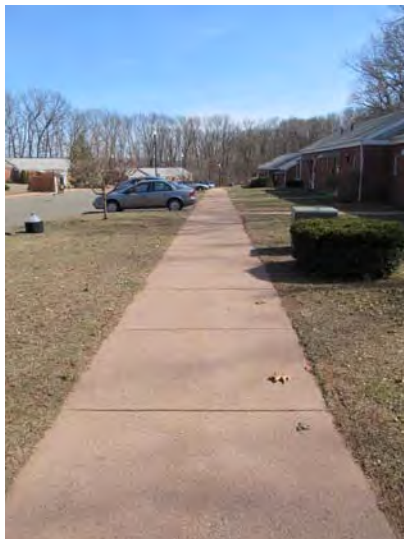
No significant cracks, displacement, or trip hazards noted at concrete sidewalks

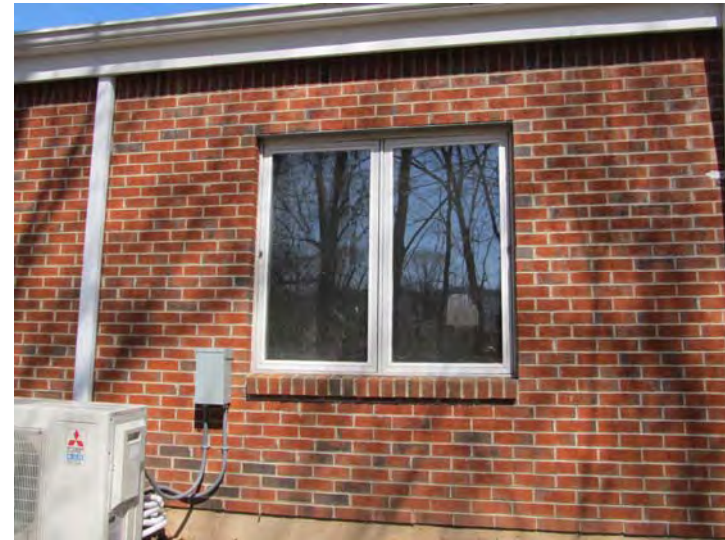
Typical original casement-style window –  
All due to be replaced in 2013

Overall the development is in generally good condition. As shown on the attached capital needs worksheets, the development faces significant capital needs in the near term, most significantly with regards to the anticipated replacement of original windows. Based on these projections, the development is seen as requiring an adjustment to current replacement reserve funding and/or an infusion of additional capital.

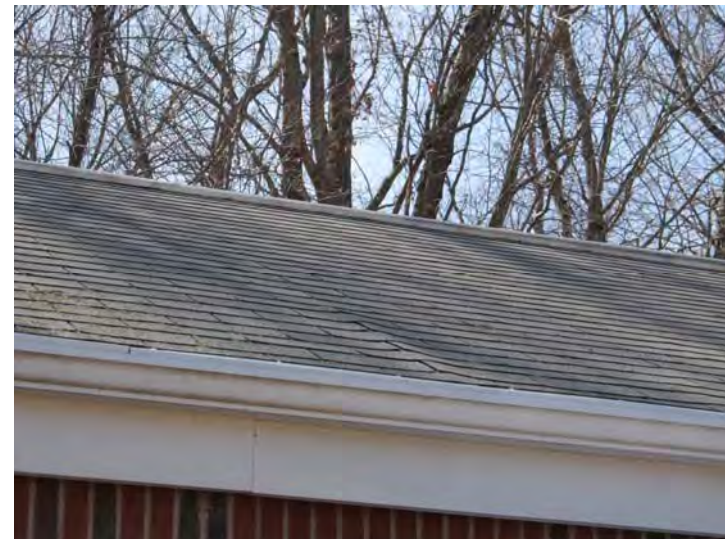
Roof shingles in fair condition – Isolated areas  
of warped/buckled roof sheathing noted

- No problems related to the roof coverings were observed or reported – isolated minor areas of sheathing deflection were noted; future costs to rip and replace all existing roof coverings are shown in Year 11.

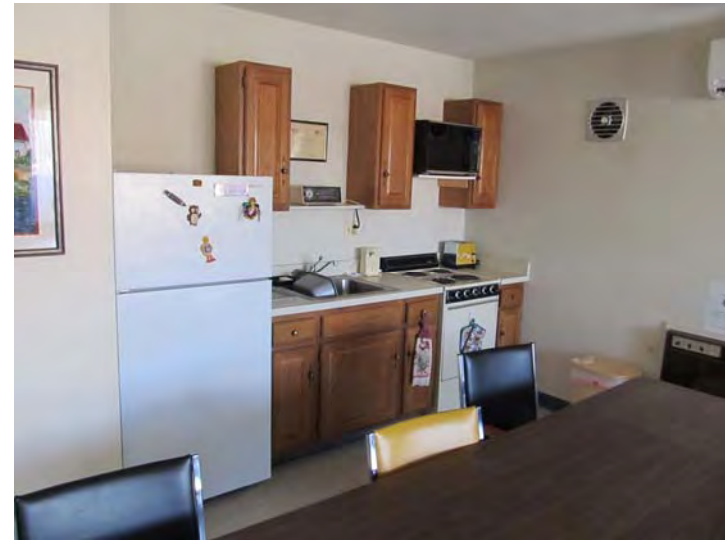
Kitchen area located at one end of community room – Note lack of knee clearance space at sink and work surface

- Common area elements requiring replacement/modification for handicap accessibility compliance include installation of a compliant threshold at the main entry to the community building, installation of accessible-style cabinetry that includes knee clearance space at the sink and a thirty-inch wide work surface in the community kitchen; and relocation of toilets, grab bars, and sinks in the common restrooms.

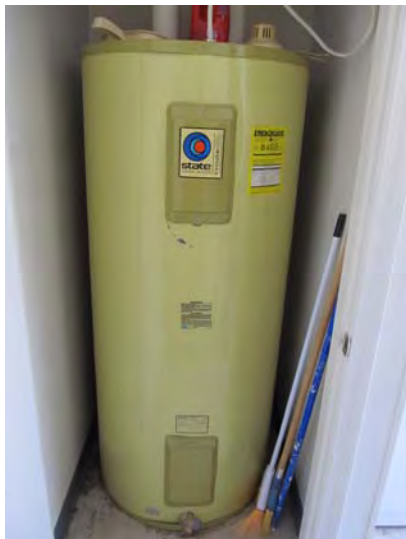
Electric domestic hot water tank serving community building – Serviceable but beyond end of expected useful service life

- No near-term needs related to the recently installed heat pump system serving the community building are anticipated. Replacement of the domestic hot water tank that serves the building is shown in Years 1 and 11.

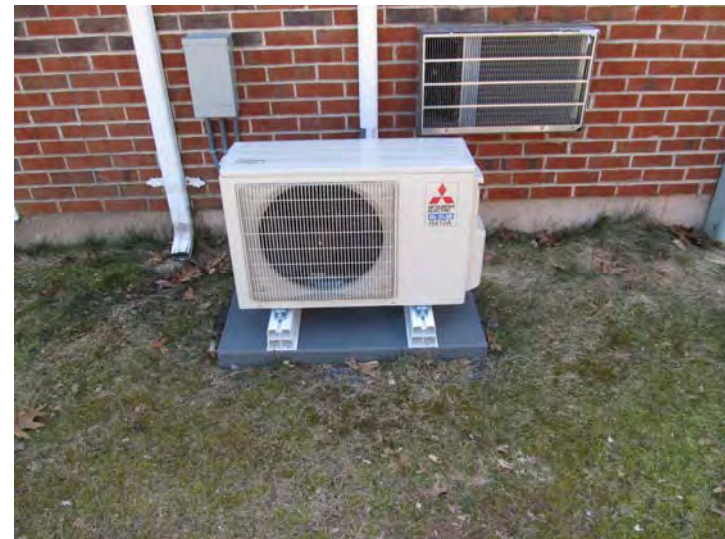
Exterior condenser for recently installed heat pump system at community building

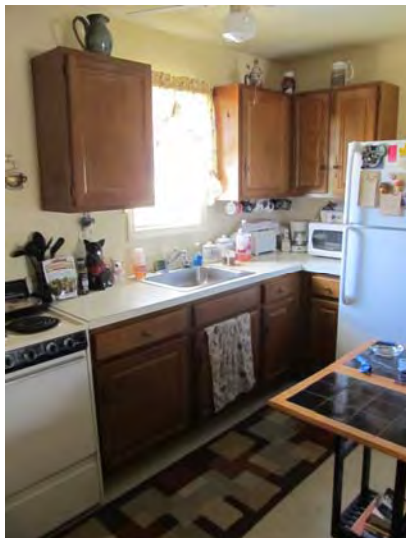
Typical finishes and equipment in 'standard' unit kitchens

- Unit bathroom fixtures are in good overall condition; allowances for future replacement/upgrade are shown in Years 11-15.
- Cabinetry in unit kitchens is original and in generally good condition for its age; future replacement is shown in Years 3-5. Allowances for appliance replacement are shown based on observed conditions, current ages, and expected useful service lives.

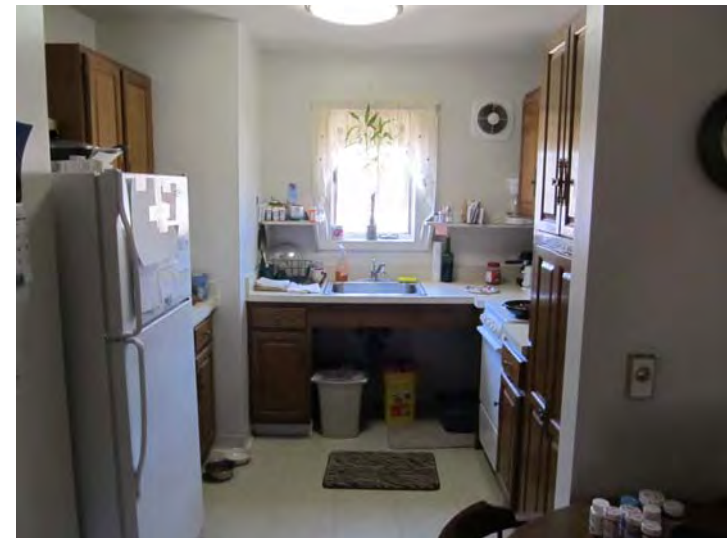
Typical handicap accessible unit kitchen – Note lack of a thirty-inch wide work surface with necessary knee clearance space

- The development's unit mix includes three handicap accessible units. Among the elements in need of modification and/or replacement for compliance with accessibility standards in these units is the relocation of toilets so as to be centered at eighteen inches from the adjacent wall, relocation of toilet grab bars, provision of a seat for use in the bathtub/shower, and installation of cabinetry with a compliant height countertop and a thirty-inch wide work surface with knee clearance space.

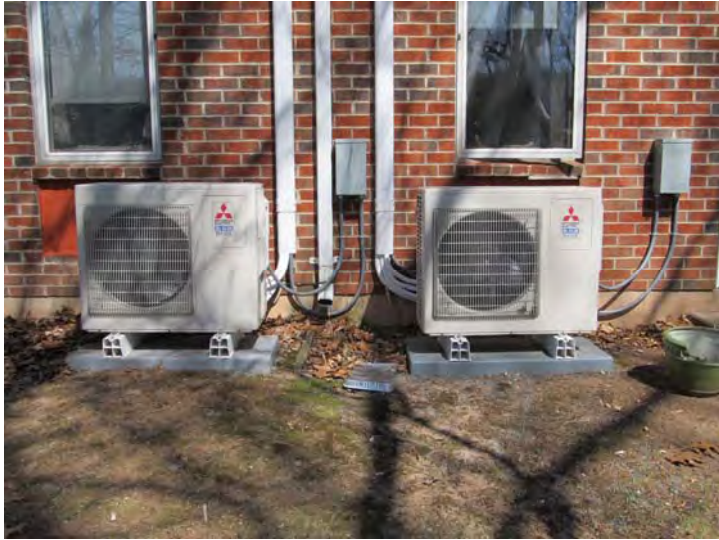
Typical exterior condensers for heat pump systems that were recently installed at all units

- Heat pump systems were recently installed at all units; no near-term needs related to these systems are anticipated. Annual allowances for the as needed replacement of in-unit domestic hot water tanks are shown from Year 1 forward.

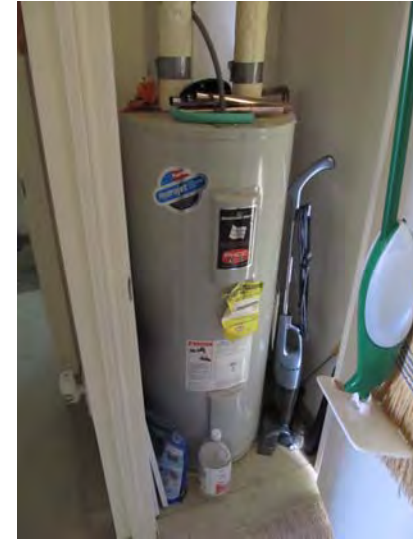
Unit-level, electric-type, domestic hot water tanks are typical throughout the development
