CHFA Capital Needs Assessment and Replacement Reserve Analysis

Rocky Hill Seniors

CHFA #85157D

Final Report

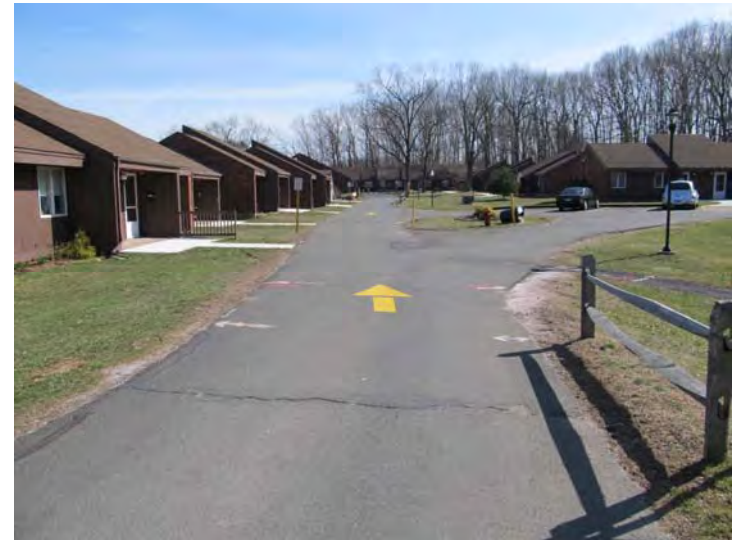
Asphalt-paved surfaces are in generally good condition for their age

- Asphalt-paved access and parking area surfaces are in generally good condition; future resurfacing is shown in Year 9.
- The recently installed concrete walkways are in excellent condition; no near-term capital needs are anticipated.

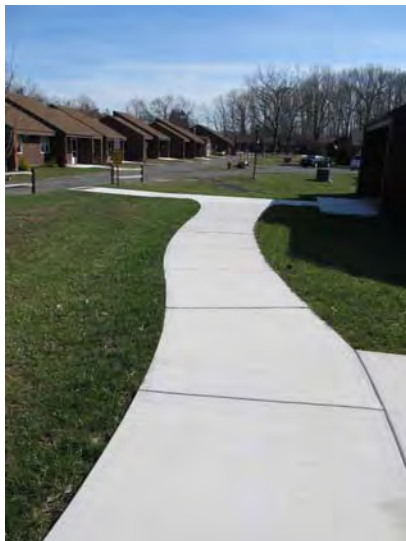
New concrete sidewalks were recently installed throughout the entire development

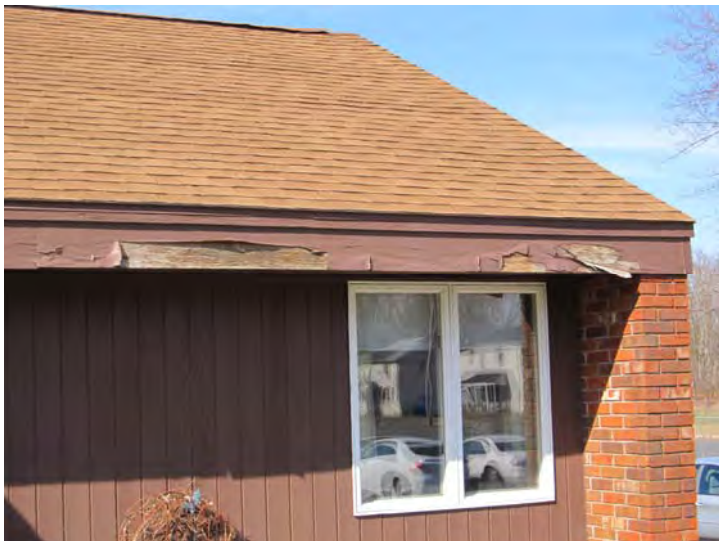
Areas of peeling paint noted on wood trim at some locations

- The painted exterior wood wall and trim surfaces are in fair condition – areas of deterioration and peeling paint were noted on some trim surfaces; periodic allowances for selective wood repair/replacement and exterior painting are shown starting in Year 1.

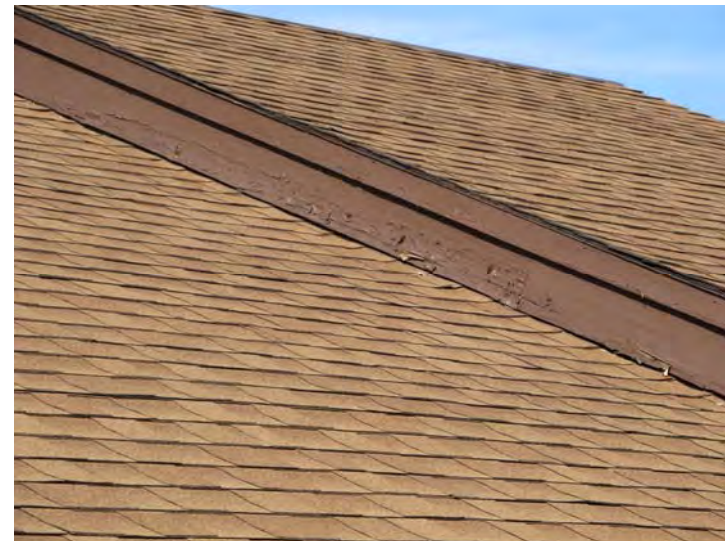
Wood rake boards at roof lines also exhibit areas of peeling paint at some locations

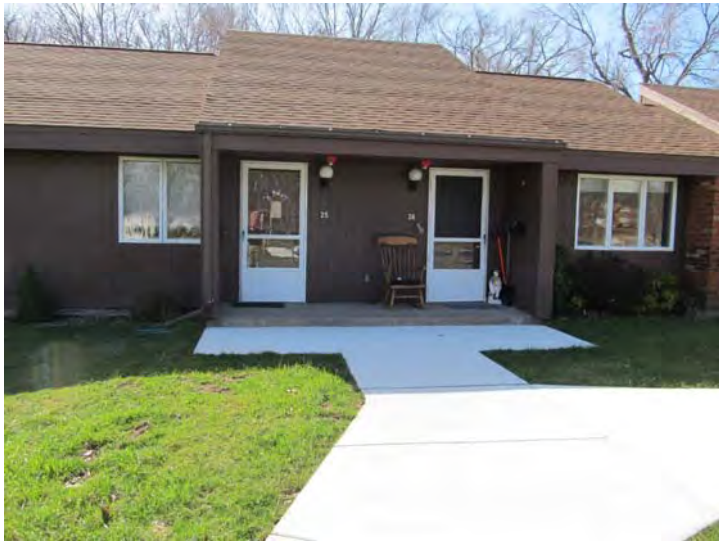
Typical unit entry doors and windows –
All in generally good condition at the present time

- Common, unit, and storm doors are shown being replaced in Year 6. Service door replacement allowances are shown in Years 1-8.
- Original windows are in fair condition for their age; future replacement is shown in Year 6.

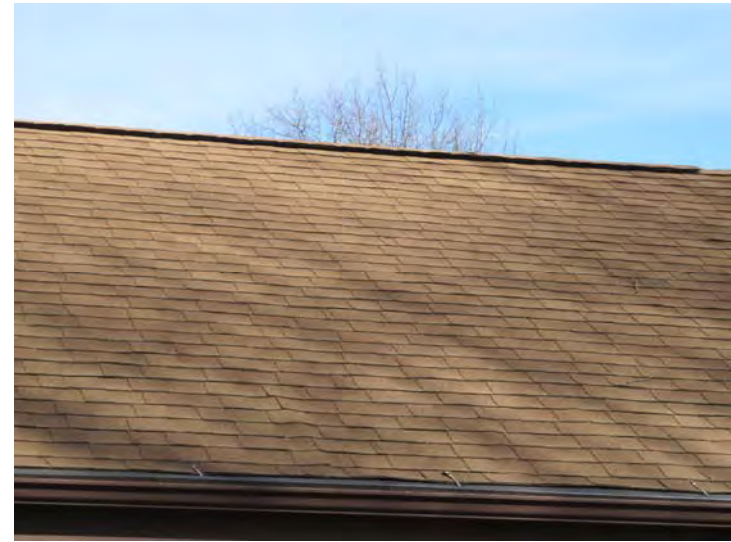
Newer architectural-style shingles that are in good
overall condition are typical on all buildings

- All buildings have newer architectural style roof shingles that are in good condition; future replacement is shown in Year 20.
- Painting/replacement of interior common area finishes is shown based on observed conditions and expected useful service life.

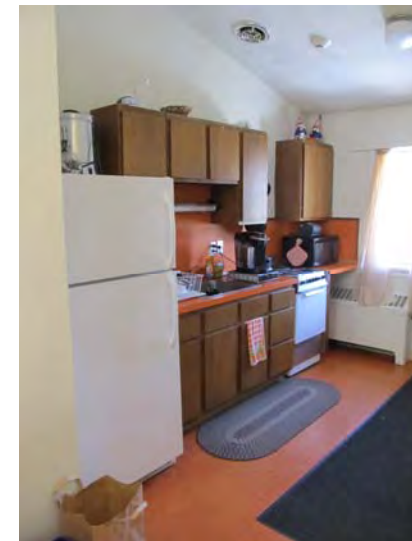
Community kitchen – Note lack of knee clearance space
under sink and a thirty-inch wide work surface

- Allowances for kitchen appliance replacement needs are shown annually based on current ages and expected useful service lives.
- Common area elements requiring replacement/modification for handicap accessibility compliance include installation of compliant-style cabinetry and provision of a compliant model refrigerator in the community kitchen, reframing of the laundry room and restroom doors so as to provide a minimum clear width of thirty-two inches, and relocation of grab bars, toilets, and sinks in the restrooms so as to be at compliant heights/distances.

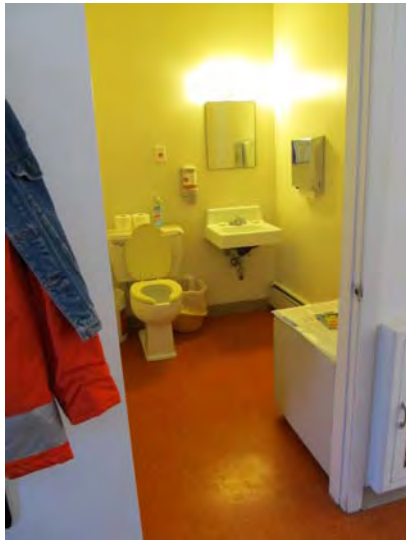
Typical common restroom at community building

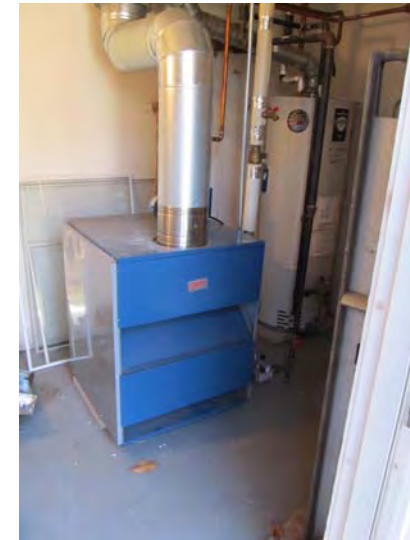
Typical central boiler and indirect-fired domestic hot water tank serving a residential building

- Each building has a central boiler and domestic hot water system – most are newer. System replacement at Building 4 is due to be completed as part of the 2013 CDBG work; no near-term needs are anticipated for the remaining systems/components.

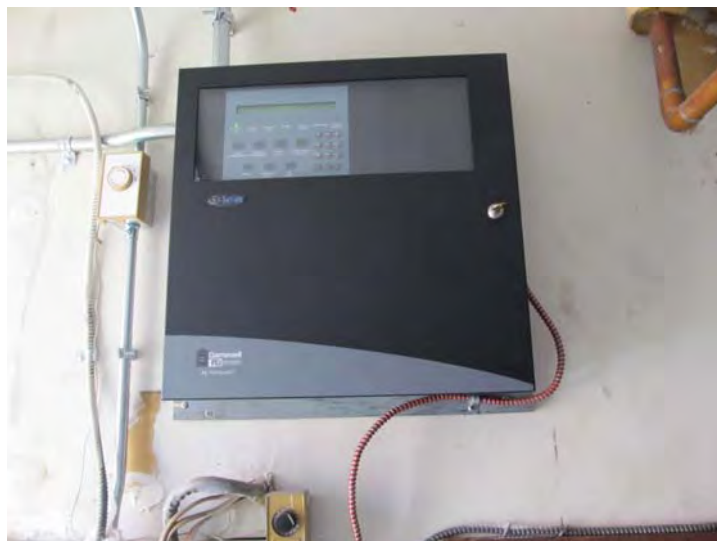
Modern, fully addressable, fire alarm control panels and new in-unit devices were recently installed throughout the development

- No capital needs related to the recently upgraded fire alarm system serving the development are anticipated.
- Annual allowances for the as needed replacement of in-unit floor coverings are shown from Year 1 forward.

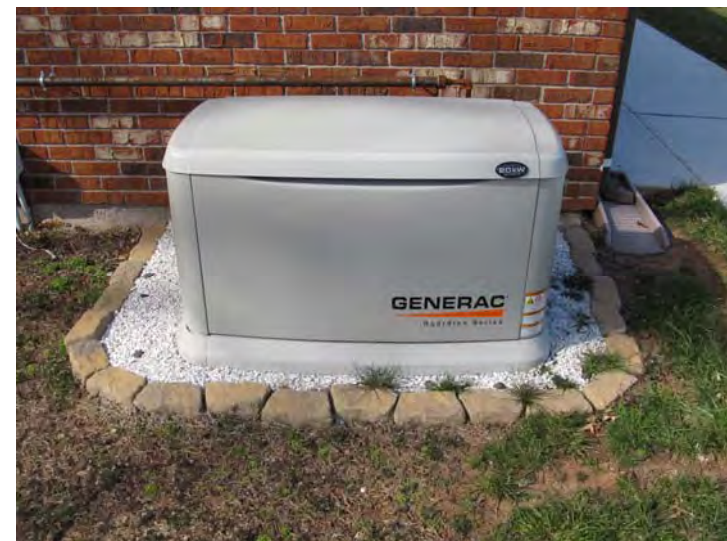
Small, recently installed, emergency generator that serves the community building

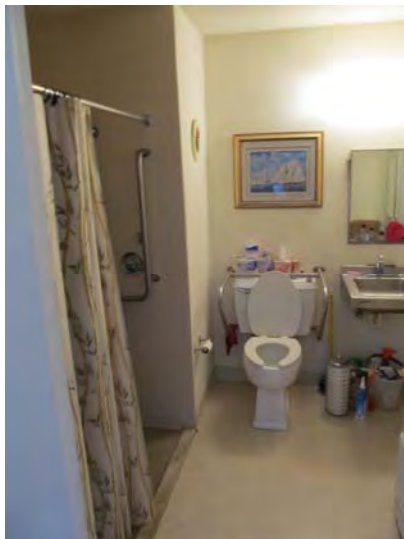
Handicap accessible unit bathrooms include roll-in showers

- The development's unit mix includes four handicap accessible units. Among the elements in need of modification and/or replacement for compliance with accessibility standards in these units is the provision of insulation on the piping under bathroom sinks and a seat for use in the bathtub/shower, and the installation of cabinetry with a compliant height countertop and a thirty-inch wide work surface with knee clearance space.
