CHFA Capital Needs Assessment and Replacement Reserve Analysis

Greenwood Manor
CHFA #85202D
Voluntown Housing Authority
Voluntown, CT

March 15, 2013

Final Report

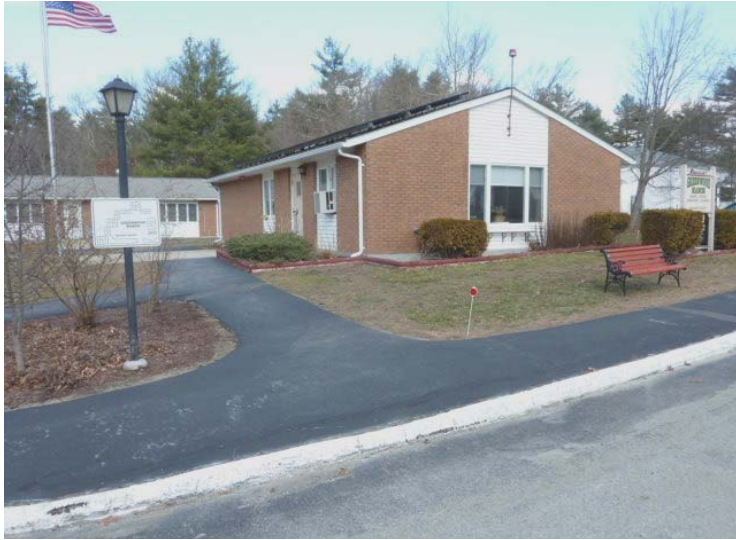
Asphalt walks at the Community Center are generally in good condition; asphalt paving elsewhere at drives, walks and curbs are generally in poor condition.

- Asphalt paving at drives and parking is shown with crack repair and sealcoat periodically during the plan and with early replacement.

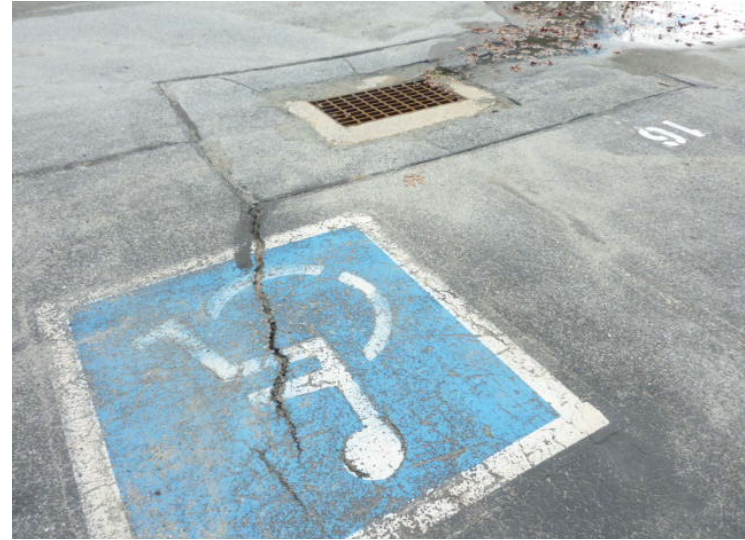
Typical asphalt drives failure.

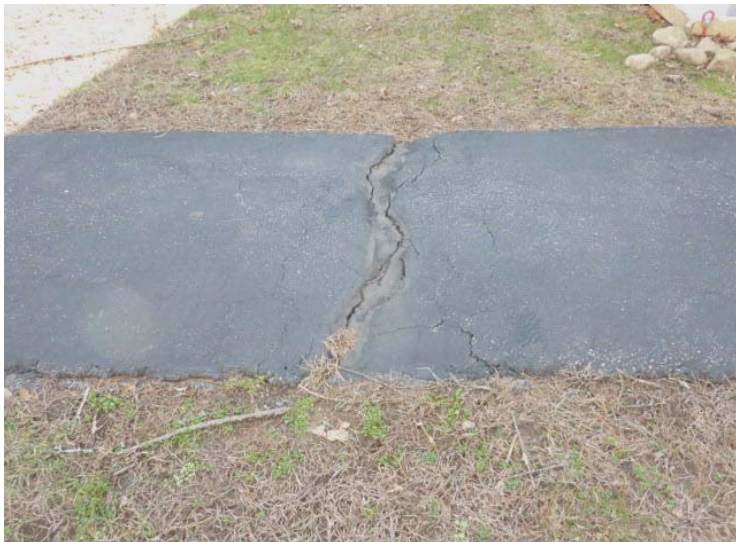
Typical asphalt walks failure.

- Asphalt sidewalks and drying yards are shown to be replaced early and late in the plan and concrete stoops replaced mid-plan.
- New site light poles are scheduled to be replaced early in the plan.

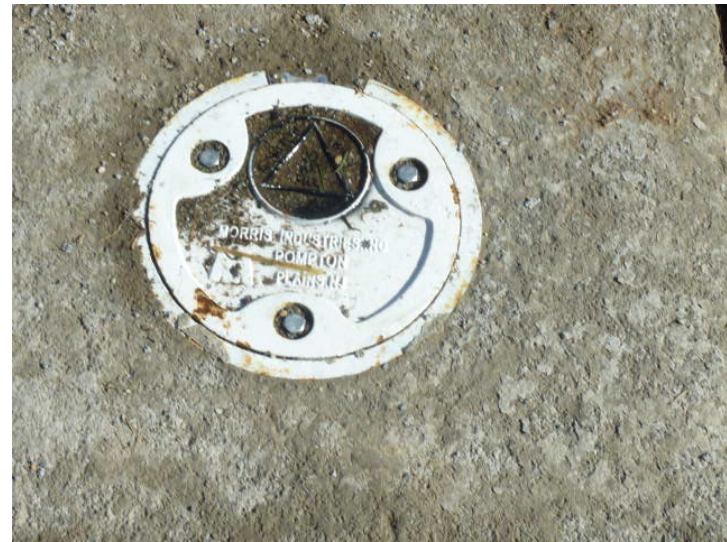
One of 5 monitoring wells installed by the State of CT to evaluate ground water down gradient from the gas station on the adjacent site to the east.

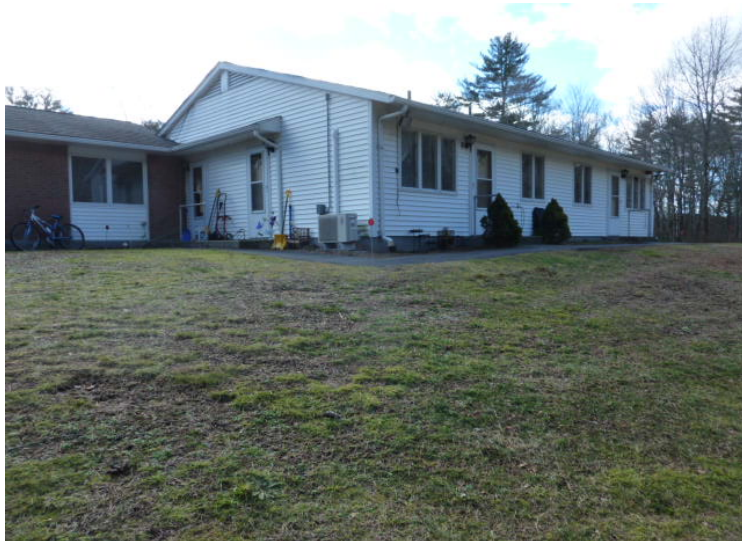
Rear of Building 2 - Leaching fields for the on-site septic systems at each of the three residential building are sited on the sloped lawns behind each of the buildings.

- Rehabilitation of the on-site septic system is shown mid-plan.
- Vinyl siding cleaning and repairs at all buildings is shown periodically throughout the plan.

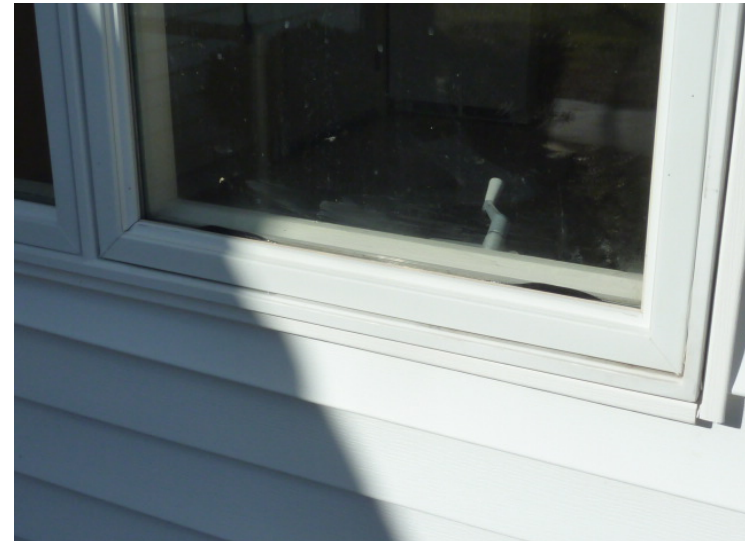
Typical gasket failure at original windows.

- New windows at the residential buildings and Community Center are shown mid-plan.
- New entry doors at the residential buildings are shown mid-plan and new storm doors at the end of the plan.

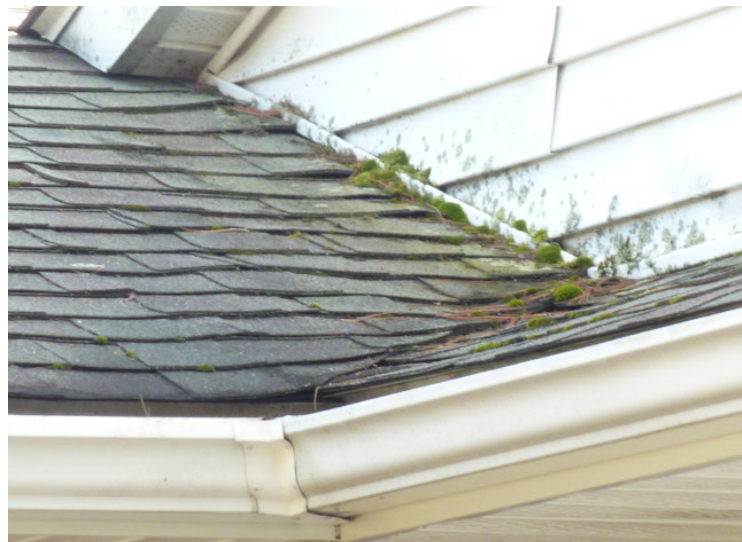
Organic growth on asphalt shingle roofs at select locations.

- Vinyl siding replacement at the residential buildings and Community Center is shown mid-plan.
- New asphalt roofing at the Community Center and residential buildings is shown late in the plan.

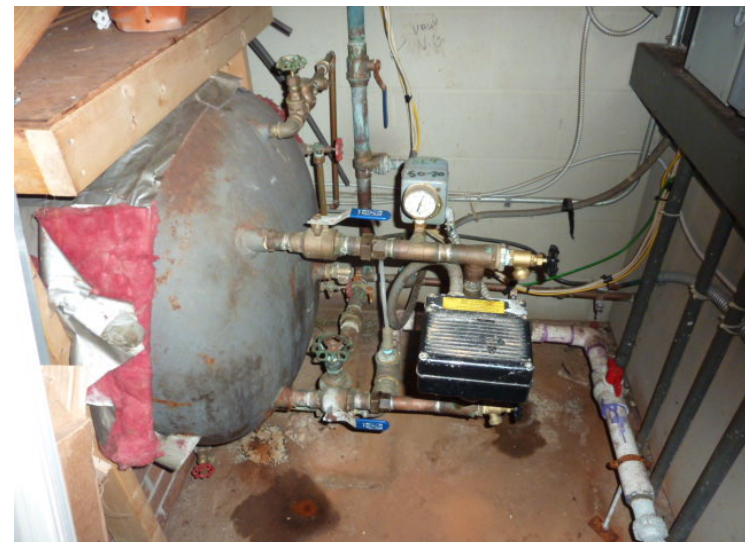
Domestic water storage tank in the Community Building is served by adjacent on-site well.

- New finishes, fixtures and appliances in the Community Center are shown periodically over the plan.
- Regular maintenance of the domestic well water system is shown over the plan and tank and pump replacement mid-plan.

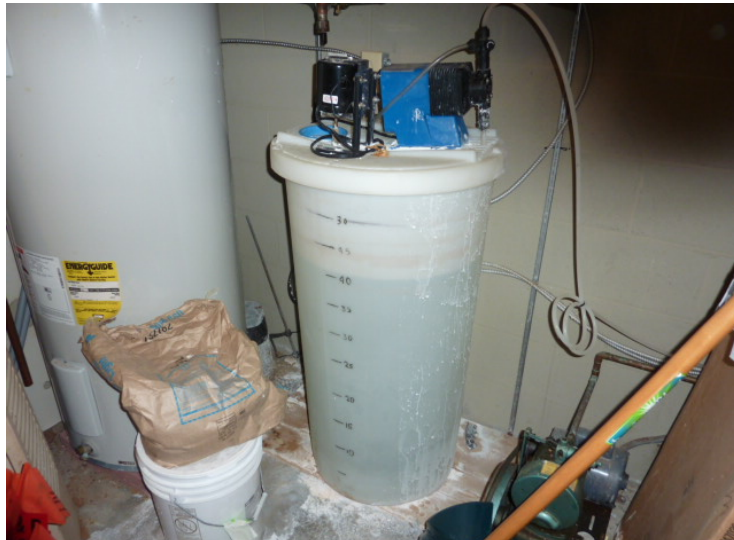
Tank for maintenance of proper PH level in domestic water from on-site well.

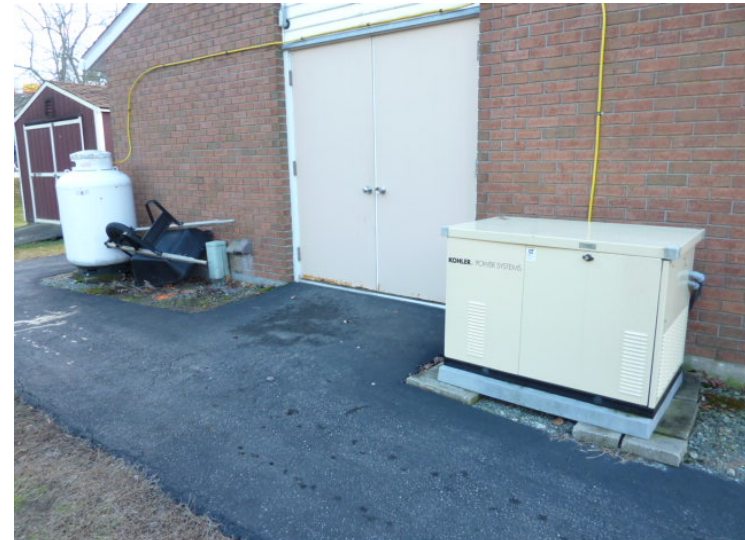
Gas-fired emergency generator and tank at the Community Center.

- New emergency generator is shown early in the plan.
- New vinyl flooring in the unit living and sleeping areas or bedrooms, bathrooms and kitchens is shown over the plan.

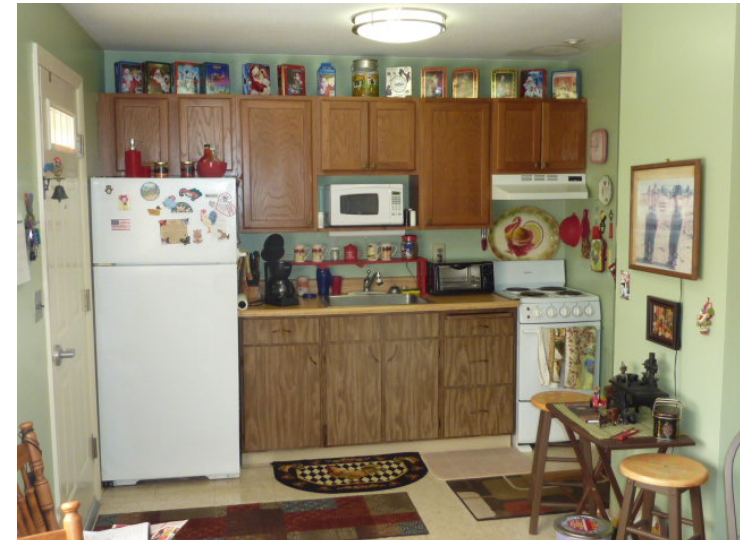
Typical kitchen in efficiency and 1-bedroom apartments.

- Kitchen cabinets, counters and sinks are shown to be replaced early in the plan.
- Kitchen ranges, range hoods and refrigerators are shown to be replaced over the plan.

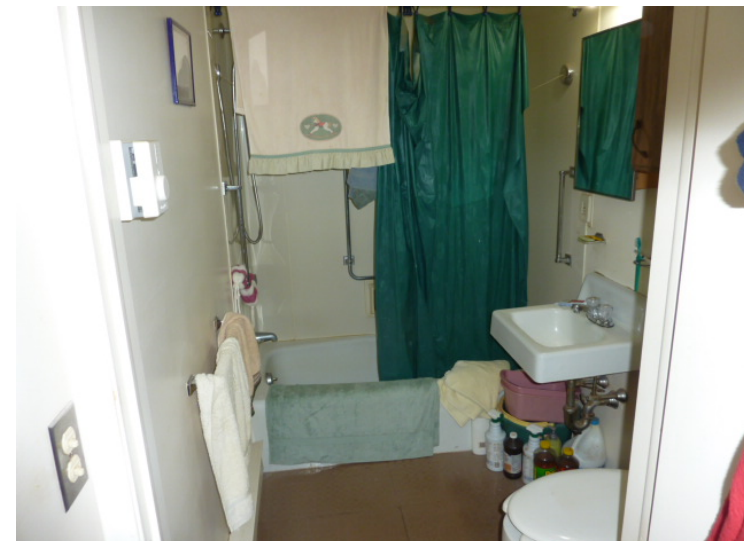
Typical tight bathroom in efficiency and 1-bedroom apartments.

- Unit wall and ceiling finishes are in good condition. General painting takes place at unit turn-over.
- Bathroom fixtures, flooring, finishes, accessories, exhaust fans and lights are shown being replaced mid-plan and late in the plan.

- CHFA requires 2 fully accessible apartments. Unit bathroom and kitchen accessibility improvements at 2 units are shown in year 1.
