# *CHFA* Capital Needs Assessment and Replacement Reserve Analysis

Plimpton House

CHFA # 88880H

*Final Report*

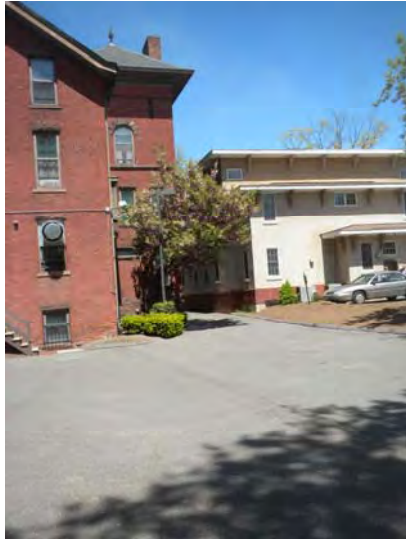
View of the rear parking area

- The asphalt paved parking area was observed to be in fair condition. Costs to resurface the parking area are shown in Year 3. Costs to replace the section of chain link fencing are also shown in Year 3.

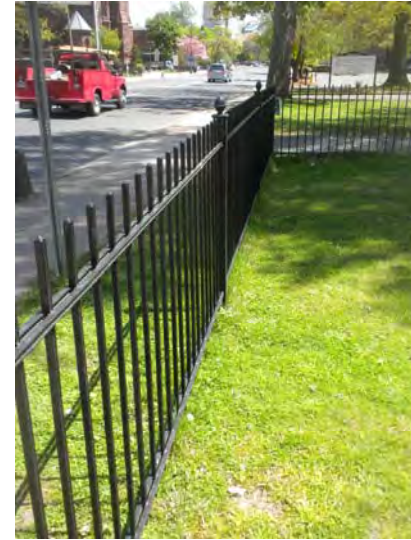
Metal picket fence along the front property line

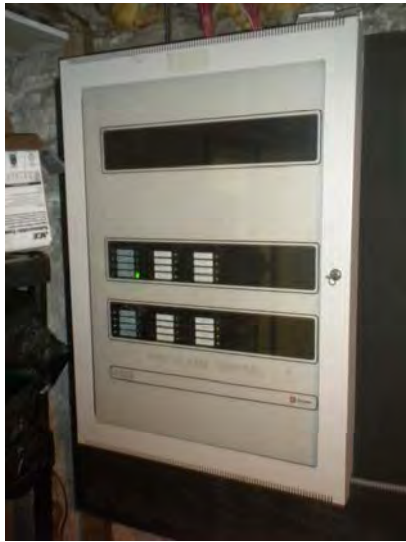
Central fire alarm control panel

- Costs to replace the central fire alarm control panel and peripheral devices are shown in Year 1.

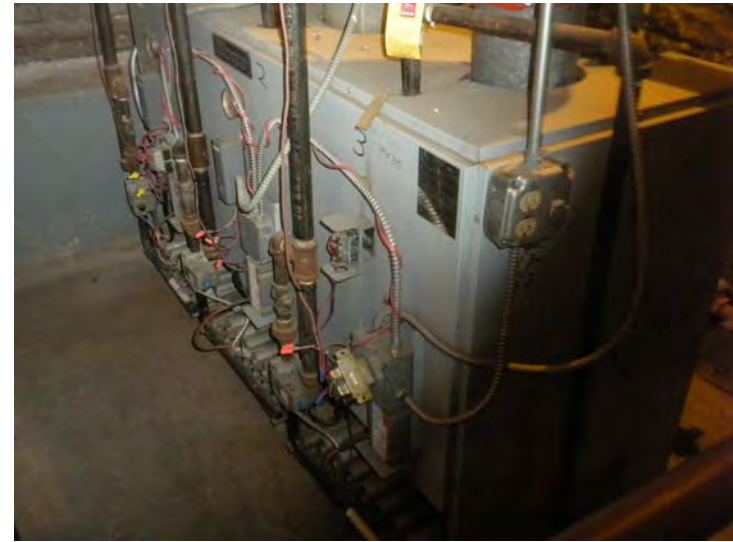
View of the central boilers –  
Estimated total capacity of 900 MBH

- The development features a natural gas-fired boiler. The boiler is estimated to have a total input capacity of 900 MBH. Future replacement costs are shown in Year 8 of the plan.

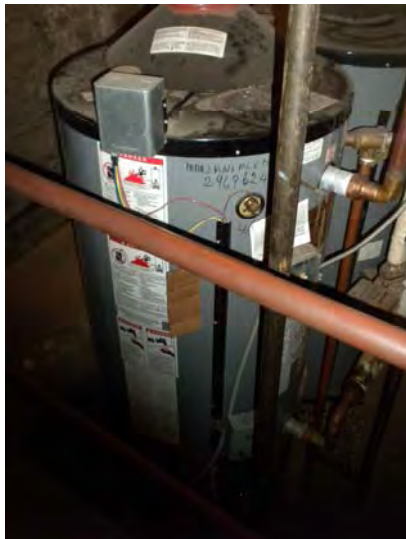
Domestic hot water tanks (one of two)

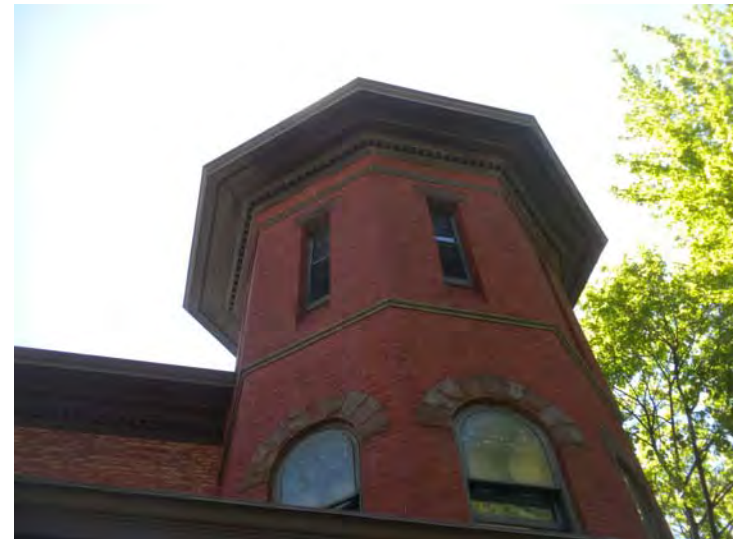
Typical building architecture

- The brick walls were observed to be in fair condition. Costs to point and repair approximately 20% of the brick walls are shown in Years 1 and 11. The original wood framed windows were restored in 1995 as part of the last major renovation. Costs to replace the windows are shown in Year 1 of the plan.

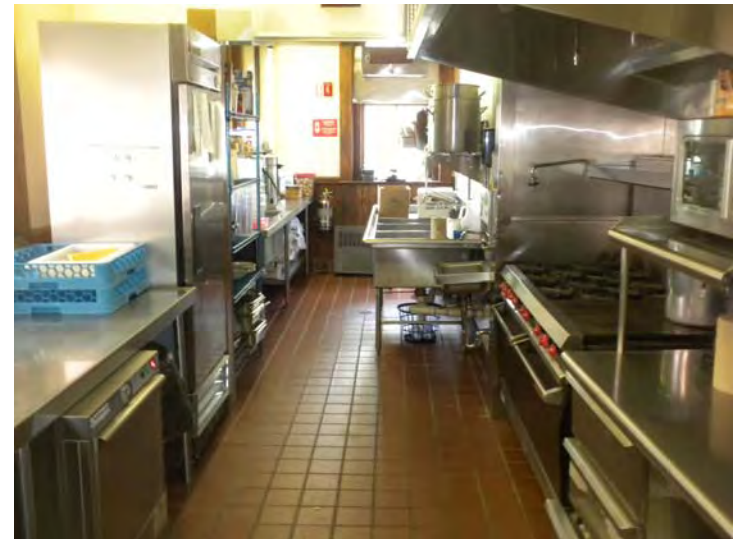
View of the commercial kitchen area

- Costs are shown to renovate the common restrooms in Years 1-3 of the plan. Cost to replace the commercial kitchen equipment is shown throughout the plan.

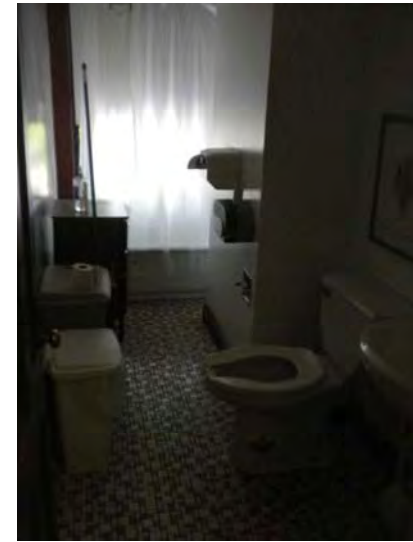
Typical common restroom
