CHFA Capital Needs Assessment and Replacement Reserve Analysis

Elms Transitional Living

CHFA #99993H

Final Report

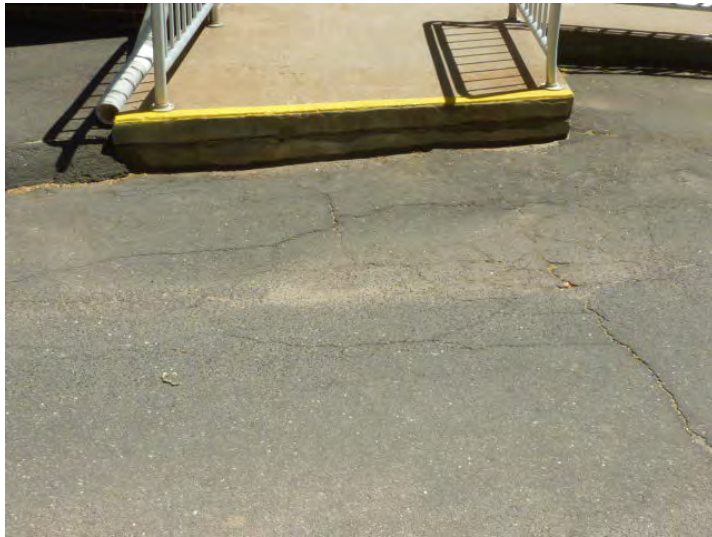
Typical cracking and sub-base failure at asphalt paving. Trip hazard is shown to be eliminated in Year 1.

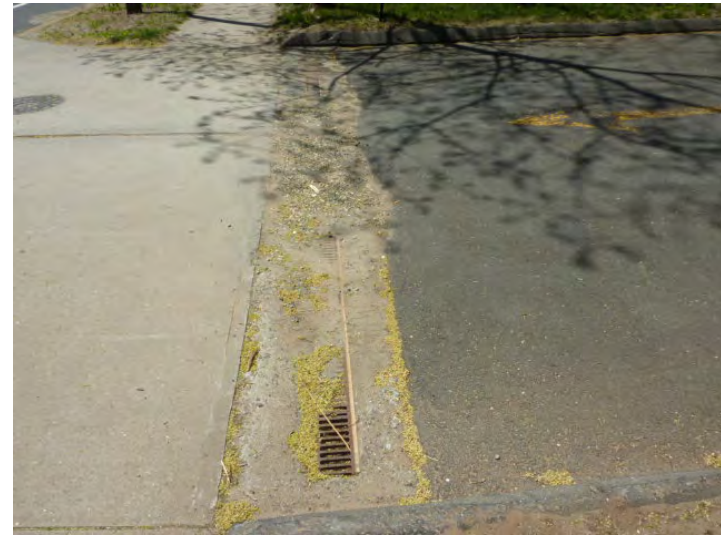
Clean and repair trench drain.

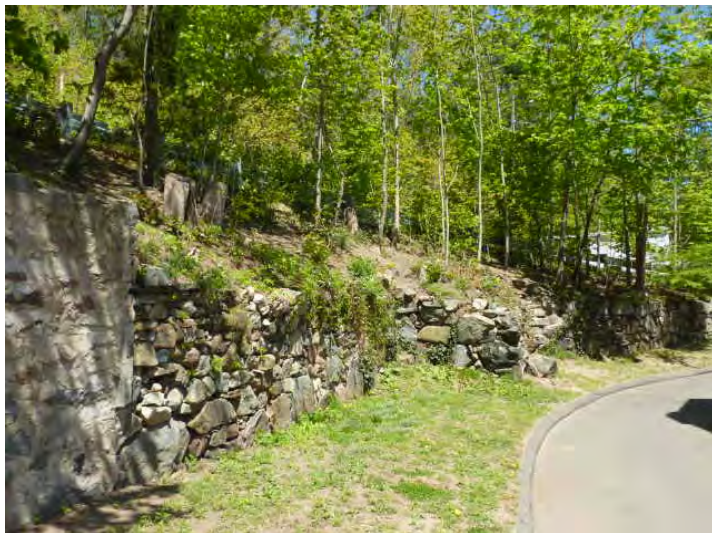
Stone retaining wall failure will continue as tree root balls behind wall continue to grow. Replacement is shown mid-term based on EUL and condition.

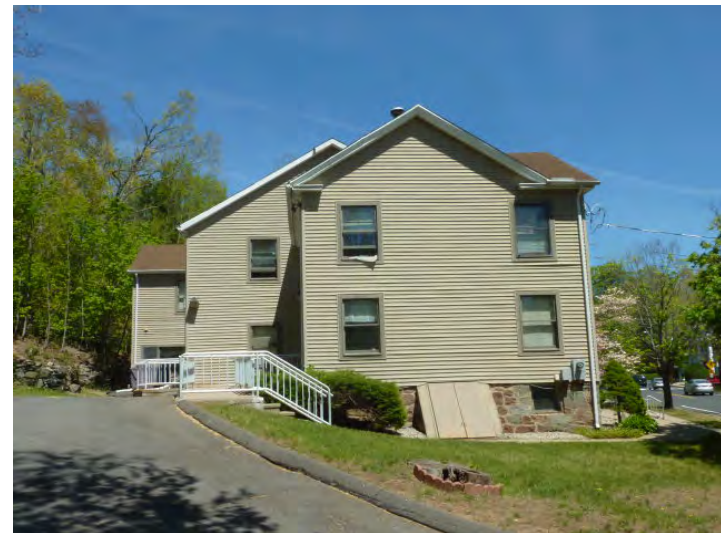
North elevation with original stone foundation wall, basement hatch door, steel pipe hand rail at stair and ramp, and several areas of buckling vinyl siding.

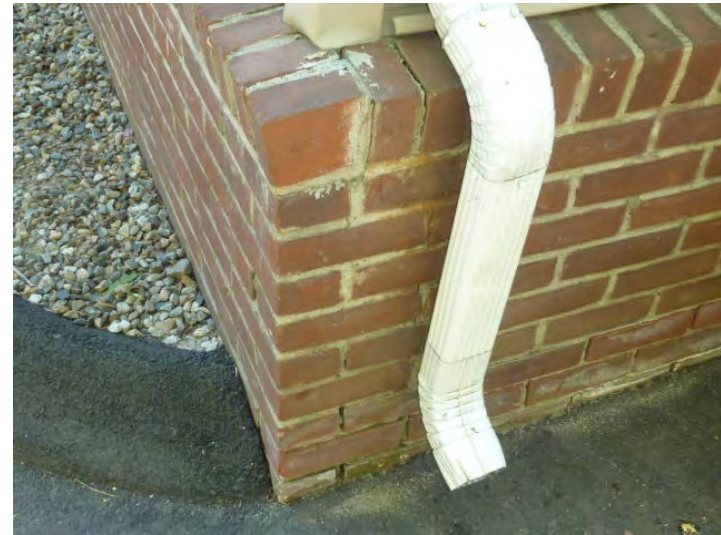
Repair and tuck-pointing of the brick water table is shown in Year 1.

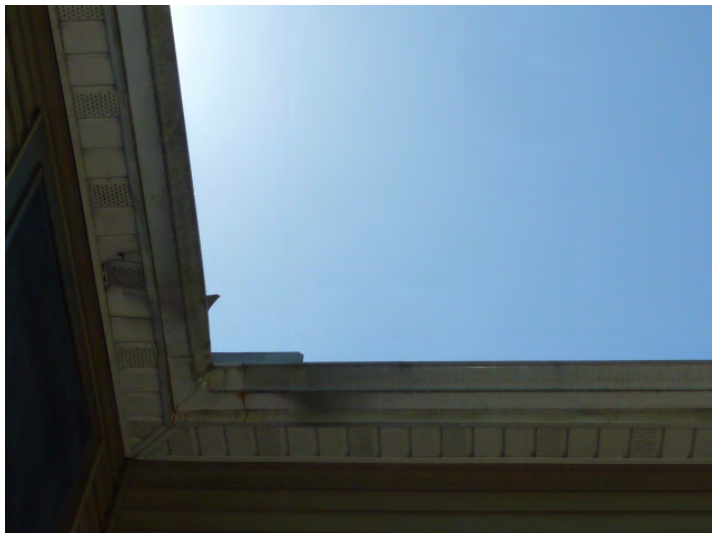
Discolored and damaged vinyl soffit and all siding is shown to be repaired through the term and replaced mid-term.

- Concrete walks, pads, and ramps are shown to be replaced mid-plan. Trip hazards are shown to be eliminated in Year 1.
- Cleaning of vinyl siding and soffits is shown periodically over the plan and replacement is shown mid-plan.

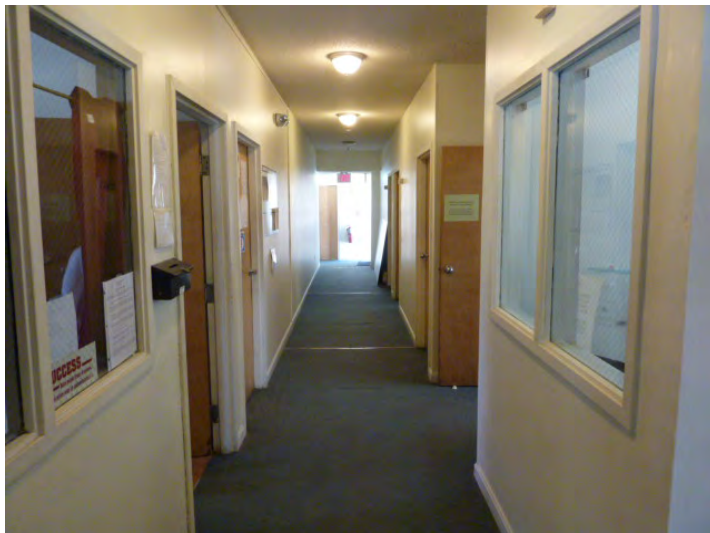
Typical first and second floor common hallway. Doors, frames and windows are not labeled with fire ratings. New fire rated doors and windows are required in Year 1.

- Floor, wall, and ceiling finish in the community, dining, meeting/exercise/library, and toilet is shown based on EUL and condition.
- Labeled, fire-rated unit doors and egress stair doors are shown to be replaced in Year 1.

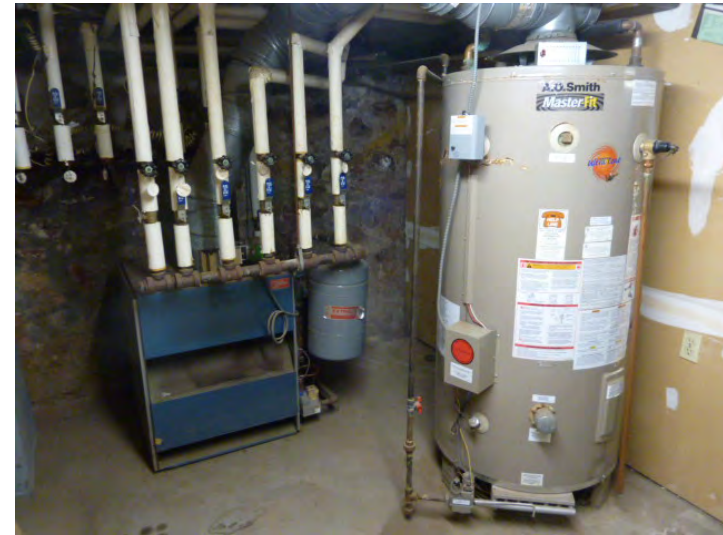
Gas-fired heating hot water boiler is original and is shown to be replaced mid-plan. Domestic hot water heater is shown to be replaced early and late.

- Floor, wall, and ceiling finishes in the common laundry, hallways, stairs, stair halls and restrooms are shown based on EUL and condition.
- New domestic hot water heaters are shown early and late in the plan.

- Heating hot water boiler replacement is shown mid-plan, and a baseboard repair/replacement allowance is shown every 5 years.
- Fire rated assemblies at the first floor/basement ceiling and walls, and fire-rated doors as required are to be provided in Year 1.

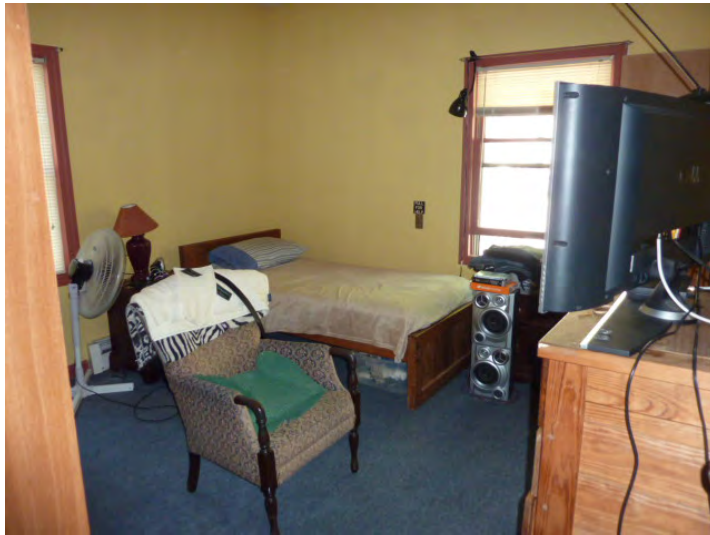
Bedroom 4 – Designated accessible bedroom with private inaccessible toilet room and a public accessible bathroom next door entered off the common hallway.

- A new Type A accessible bathroom is shown in Year 1.
- The replacement of smoke detectors is shown are shown early, mid and late-plan.

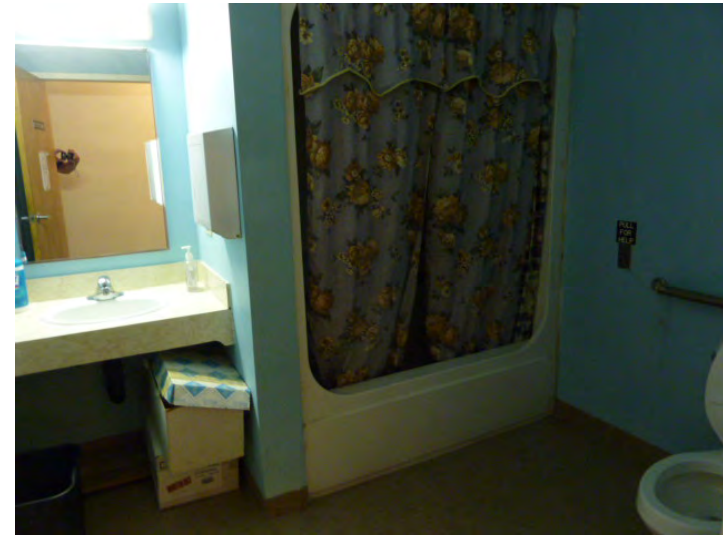
Designated public accessible bathroom adjacent to Bedroom 4.

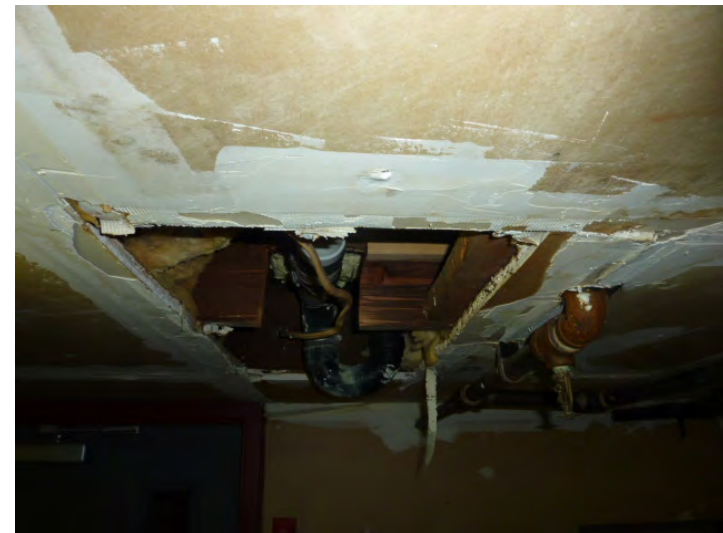
Basement ceiling is required to be a fire-rated assembly. All openings in fire rated ceilings and walls are required to be properly sealed in Year 1.
