CHFA Capital Needs Assessment and Replacement Reserve Analysis

Fairfield Ridge Rehab
CHFA # 85026D
Danbury Housing Authority
Danbury, CT

July 9, 2013

Final Report

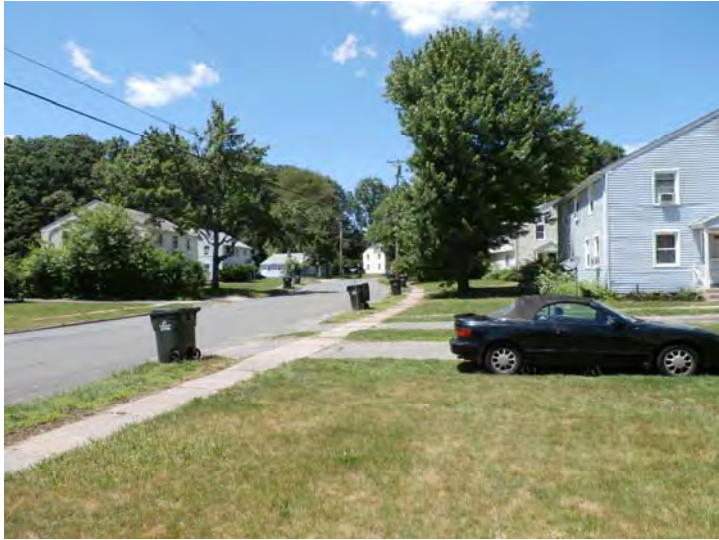
Typical asphalt driveway and concrete walk

- Costs to replace/resurface the asphalt paved unit driveways are shown in Years 1-5
- Annual allowances are shown for as needed concrete repairs to unit walkways and sidewalks
- Management reported failures of supply lines from municipal and utility supplied service mains. Annual allowances for as needed repairs are shown throughout the report.

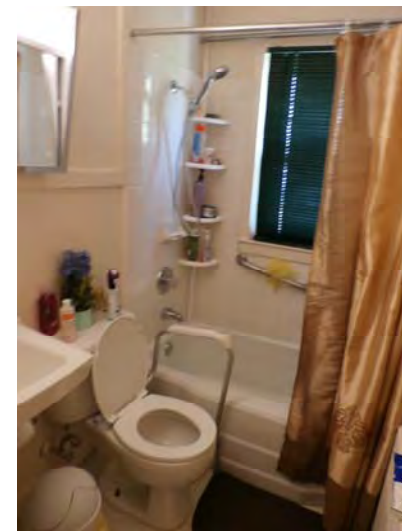
- Most units have their original enameled steel wall hung sinks with two handle water control faucets. Costs to replace these sinks and faucets are shown in Years 1-10.

- The toilets are older high water flow (3-GPF or greater) models. Costs to replace these toilets with lower flow 1.6-GPF models are shown in Years 1-10.

Typical bathroom sink and toilet area
