CHFA Capital Needs Assessment and Replacement Reserve Analysis

Mill Ridge

CHFA # 85025Z

Final Report

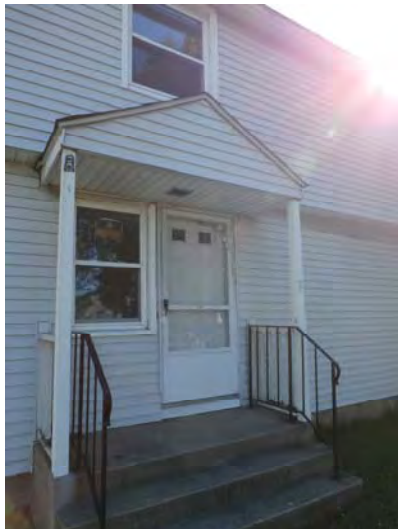
Typical front entry door, porch, and stoop

- Annual allowances to replace entry lighting and repairs to the entry porches and concrete stoops are shown on an as needed basis throughout the report.
- Costs to replace the asphalt shingle roof covering systems are shown in Years 15-19. Annual allowances to repair/replace sections of the aluminum gutters and downspouts as needed are shown throughout the report.

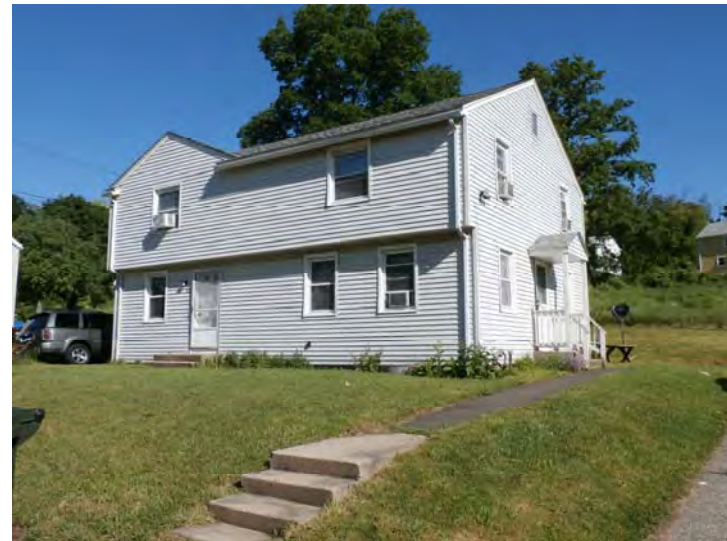
Typical duplex front elevation

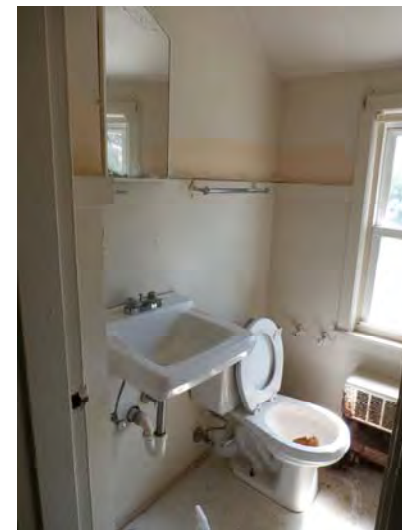
Typical bathroom sink and toilet area

- Most units have their original enameled steel wall hung sinks with two handle water control faucets. Costs to replace these sinks and faucets are shown in Years 1-10.

- The toilets are older high water flow (3-GPF or greater) models. Costs to replace these toilets with lower flow 1.6-GPF models are shown in Years 1-10.

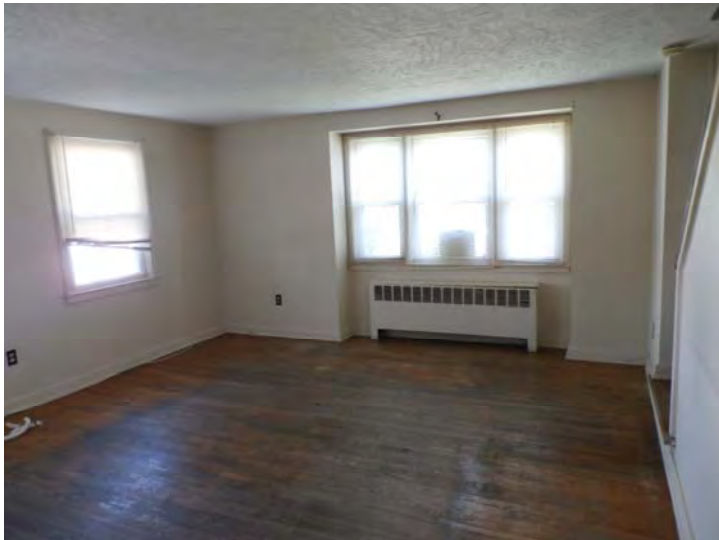
Typical hardwood living room flooring

- Living area flooring is bright finished hardwood (HW) or commercial vinyl composite tile (VCT). Costs for refinishing the HW flooring are shown on fifteen year cycles throughout the report. Replacement costs for the VCT flooring are shown on ten year cycles throughout the report.

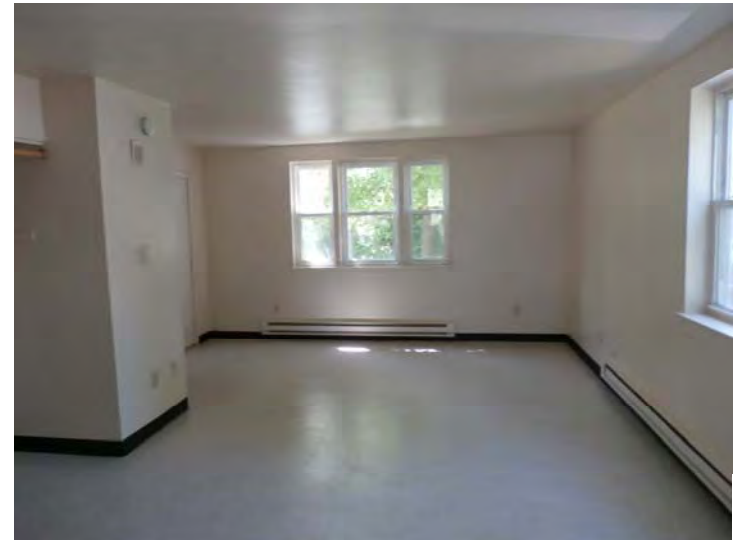
Typical living room with VCT flooring
