CHFA Capital Needs Assessment and Replacement Reserve Analysis

Amistad Court Cooperative

Amistad Court Cooperative
Hartford, CT

August 2, 2013

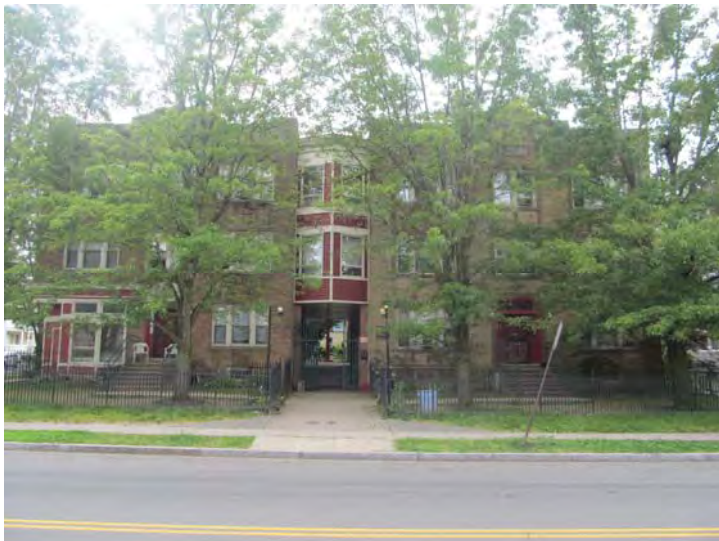
Building architecture as seen at front elevation

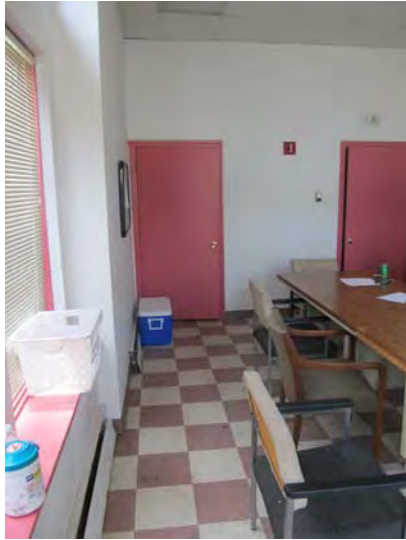
- Finishes in the community room, common stairways, and restroom are in fair to good condition; future painting and floor covering replacement allowances are shown in Year 5.

Community room

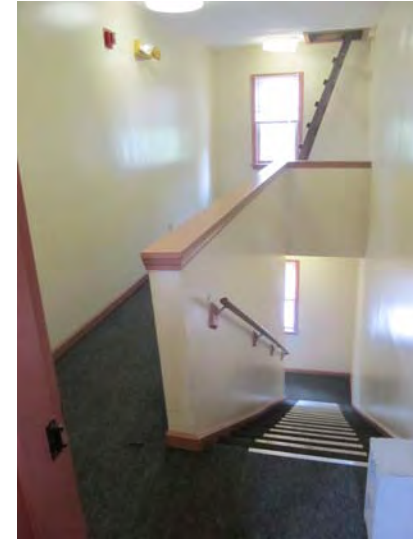
Typical finishes at common stairways

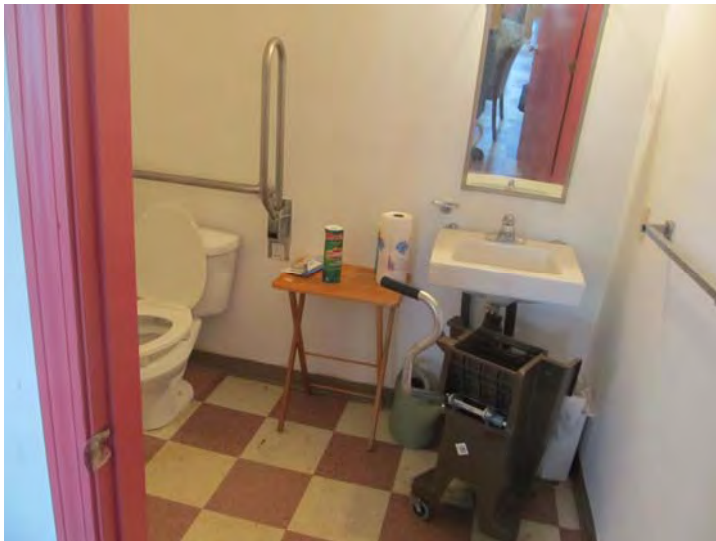
Common restroom located
off of community room

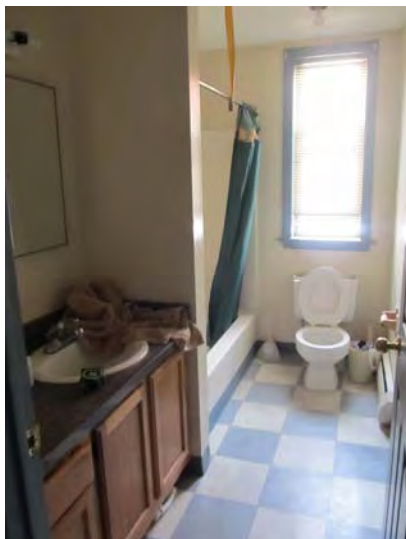
- Carpet on unit living area floors exhibits stains and age-related wear; initial replacement of all carpeting is shown in Years 1-3.
- No significant wear or damage was noted with regards to bathroom fixtures or finishes; future upgrades are shown in Years 4-6.

Typical finishes and fixtures in unit bathrooms

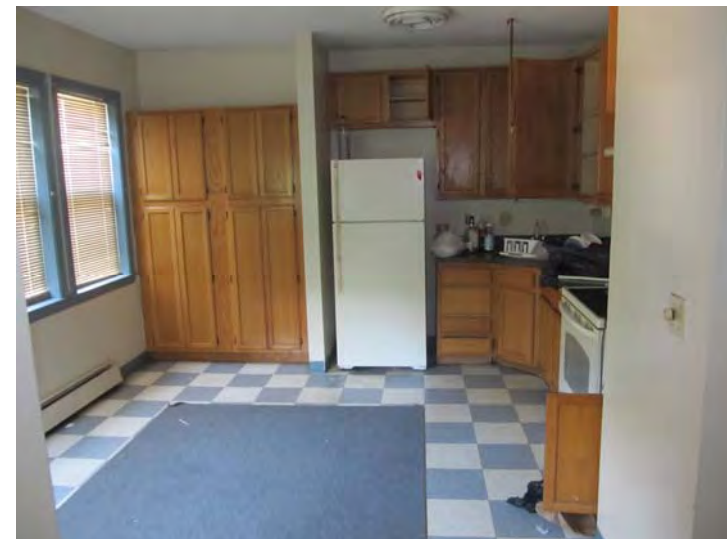
- Cabinetry in unit kitchens is in generally good condition; future replacement is shown in Years 4-6. Appliance replacement allowances are shown based on observed conditions, current age, and expected useful service life.

Typical finishes and equipment in unit kitchens
