CHFA Capital Needs Assessment and Replacement Reserve Analysis

M.J. Caruso Gables
CHFA #94035D
Imagineers, LLC
Hartford, CT

April 17, 2013

Final Report

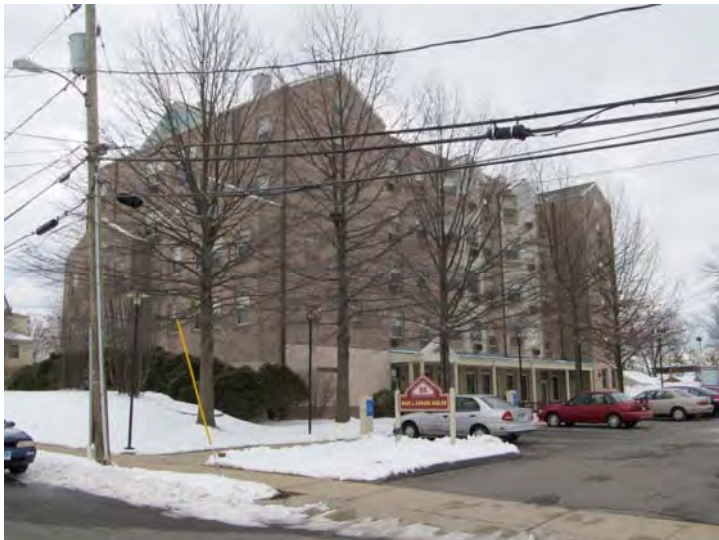
Building architecture as seen at front and side elevations

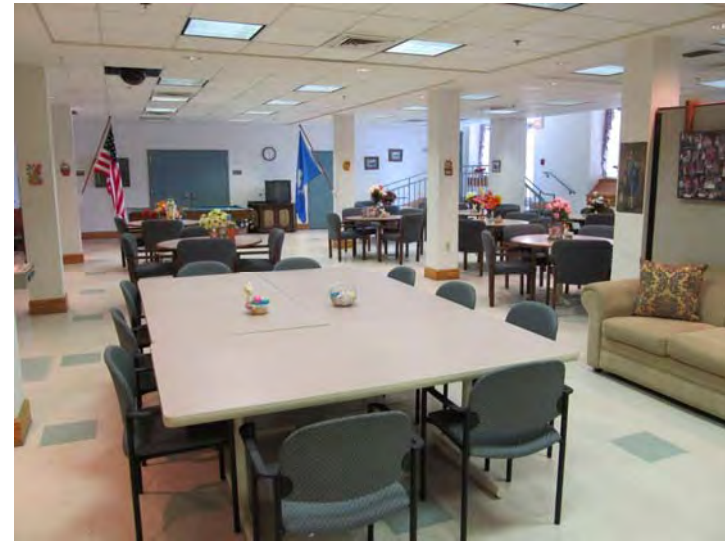
Community room

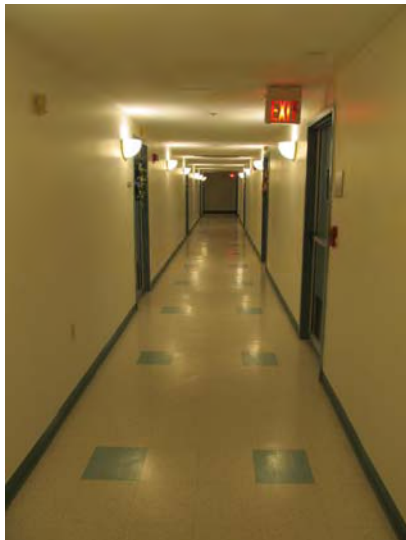
Typical finishes in common hallways

- Interior common area finishes are in generally good condition; an initial painting cycle is shown in Year 2; ceiling tile and floor covering replacement allowances are shown later in the plan based on current condition and expected useful service life.

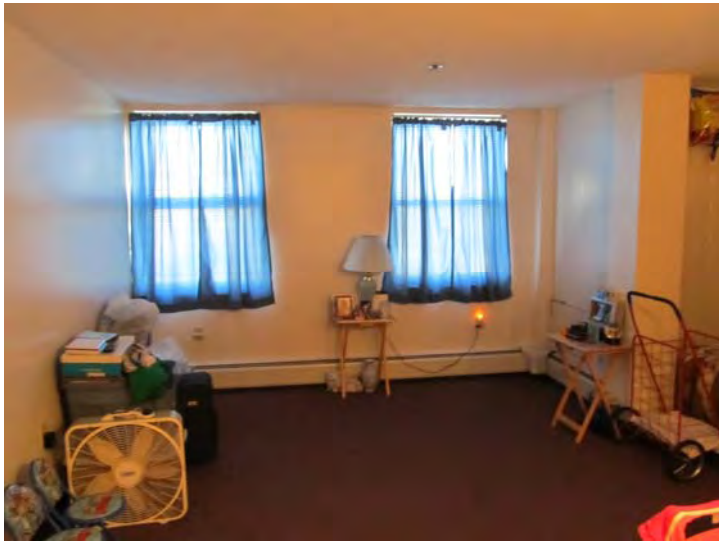
Typical finishes in unit living areas

- No problems related to the hydraulic elevator serving the building were noted; a major system upgrade is shown in Year 16.
- Annual allowances for the as needed replacement of in-unit floor coverings are shown from Year 1 forward.

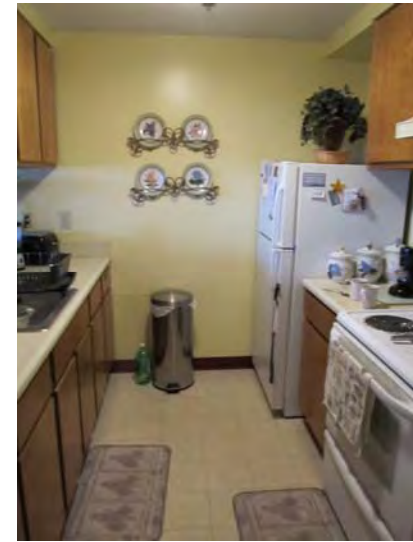
Typical finishes and equipment in unit kitchens

- Kitchen cabinetry is original and in fair condition; future replacement is shown in Years 5-7. Annual allowances for replacement of ranges and refrigerators are shown from Year 1 forward.

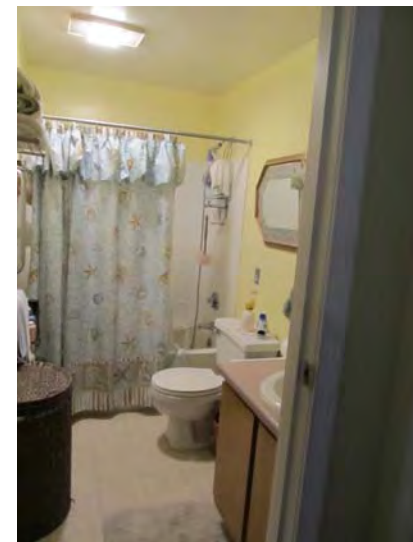
Typical finishes and fixtures in unit bathrooms

- Allowances to replace existing toilets with low-flow models are shown in Years 2 and 3. Future replacement of bathtubs, surrounds, and mixing valve assemblies are shown in Years 6-11. Sink and vanity replacement is shown in Years 5-7.
