PARKSIDE GABLES APARTMENTS

Physical Capital Needs Assessment

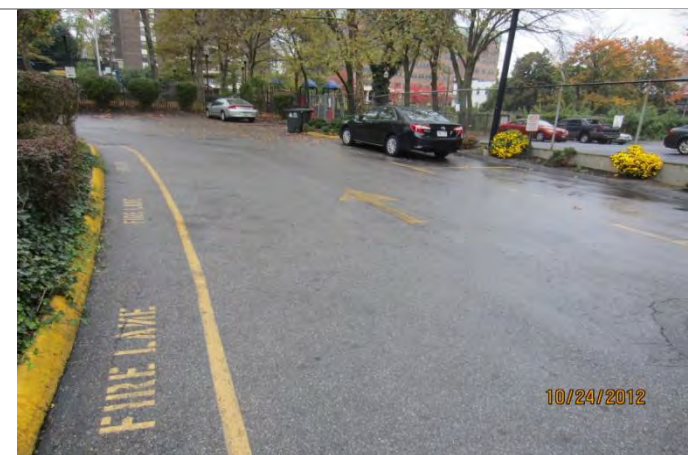
Main Driveway

The project has one small driveway/parking area at Building 1, a small parking area between Buildings 5, 6, 7, and a larger parking lot and driveway throughout the remaining area of the project. The parking was found to be in fair condition structurally, i.e., if the potholes and cracks are repaired, the asphalt will continue to wear well. The parking lot and driveway totals an area of 12600 SF and there is 4410 SF of cracks, potholes, and damaged areas. An overlay of the entire parking area has been included as an **immediate need**.

The parking area has been included for slurry seal, crack fill, and striping on five year cycles starting in Year 3, covering the entire 12600 SF of the parking and driveway. Sealing, slurry-seal, and restriping have been included in **Year 0, 5, 10, 15, and 20** of the report based on a five year cycle. As an immediate need, the handicapped parking space at 107 and in the rear of Building 7 and at Building 1, the van accessible hash-marks do not provide an even area for accessible exit under UFAS specifications; this **immediate need** has been included.
