CHFA Capital Needs Assessment and Replacement Reserve Analysis

Prospect House

Recovery Network of Programs, Inc
Bridgeport, CT

Final Report

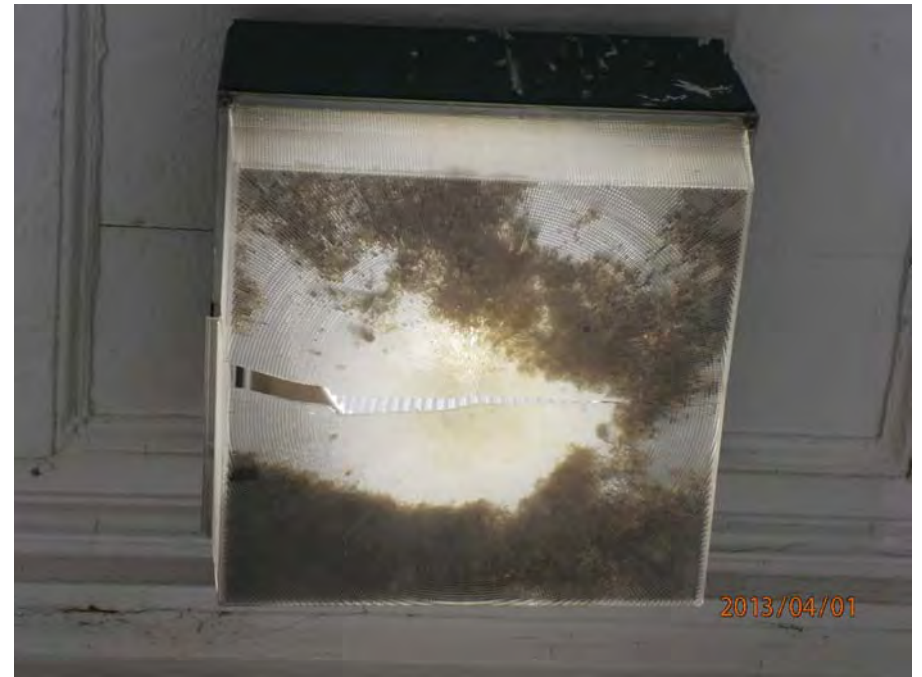
6. Damaged exterior light fixture

- Many of the exterior building components and systems are at the end of their expected useful lives. Allowances for replacement and/or repair of the entry and roof access doors, windows, window lintels, and building mounted light fixtures are shown in Year 1.
- Replacement of the main entrance wood columns, roof railings, and ceiling components are shown in Year 1. Repairs and painting of the bay window components are shown in Year 1. Brick pointing, waterproofing, and caulking are also shown in Year 1.
- An allowance for replacement of the build-up roof and parapet walls with a single ply membrane roof system is shown in Year 7.
- Common area lobbies, hallways, stairways, kitchen, offices, and lounge/community rooms receive ongoing use and are shown for upgrades and improvements beginning in Year 1 and throughout the plan.

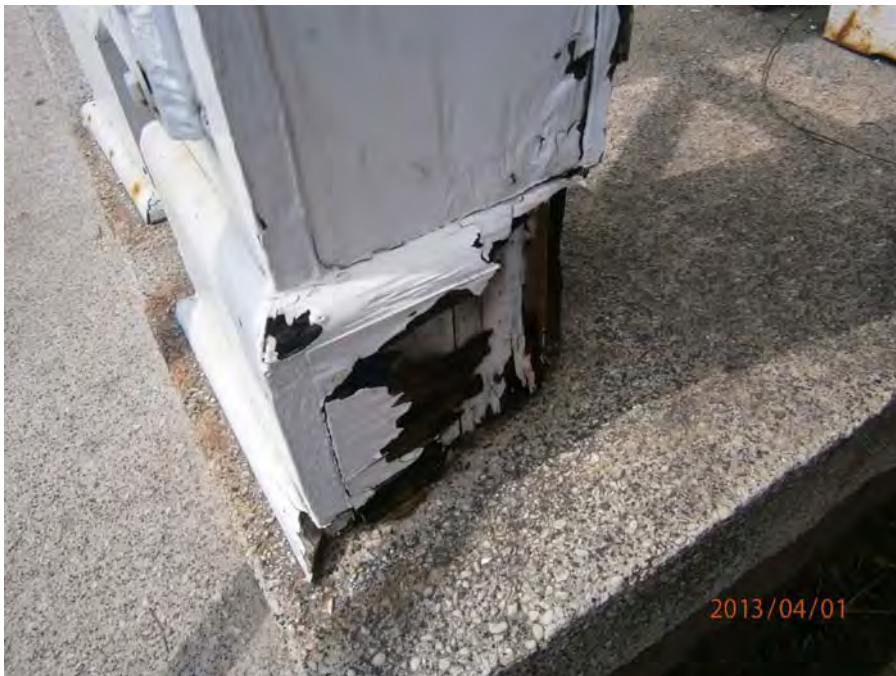
7. Damaged entrance pillar

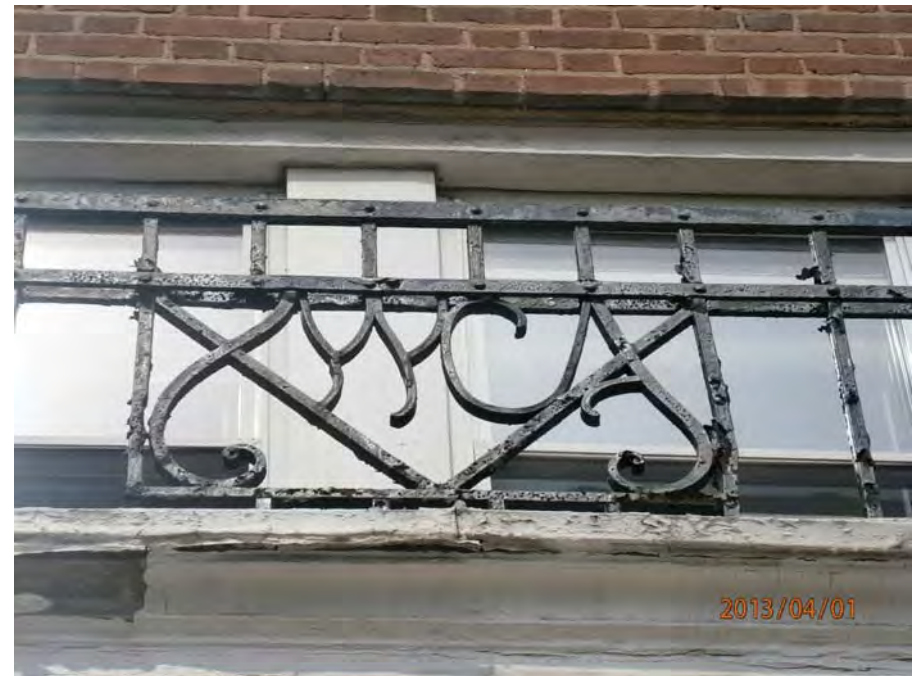
8. Decorative roof railing deteriorated

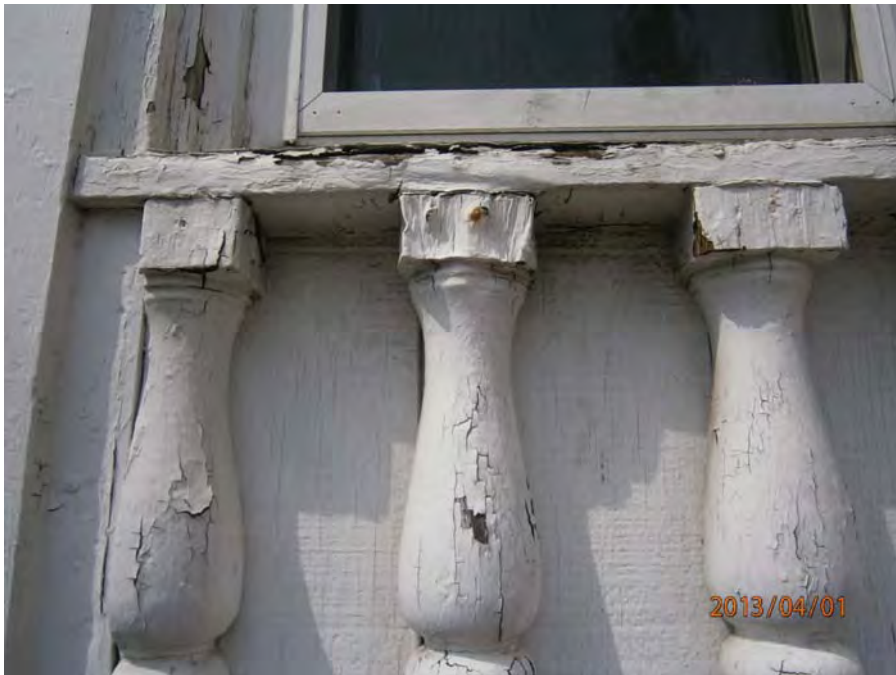
9. Bay window components damaged

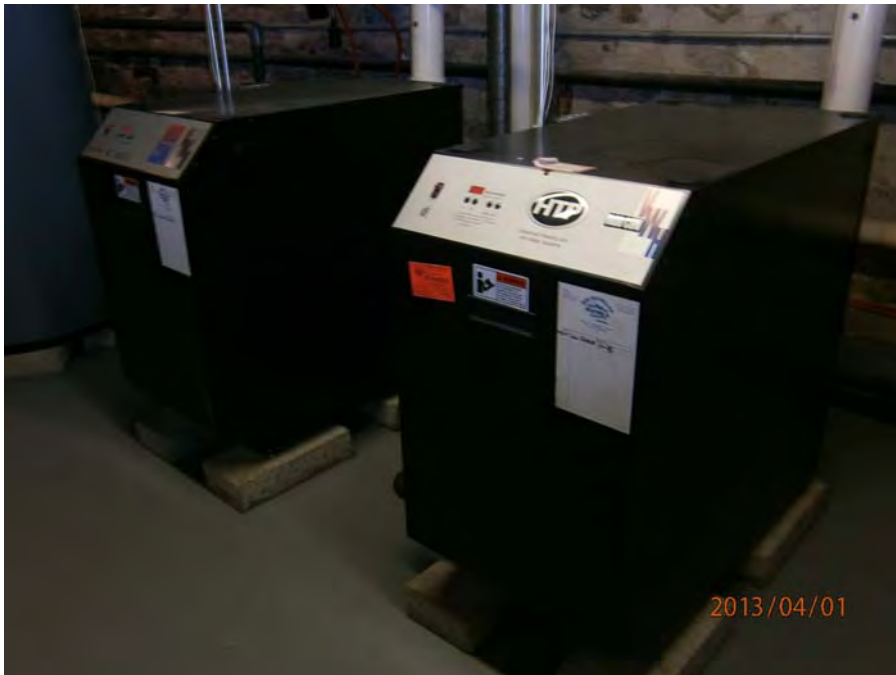
17. DHW system installed 2011

- Replacement of the boiler is shown in Year 18. The domestic hot water system was installed in 2011, and no problems were reported or observed in regard to these components. Management expressed problems with the heating distribution piping leaking. An allowance for upgrades and repairs to the heating risers and distribution piping is shown in Year 1.

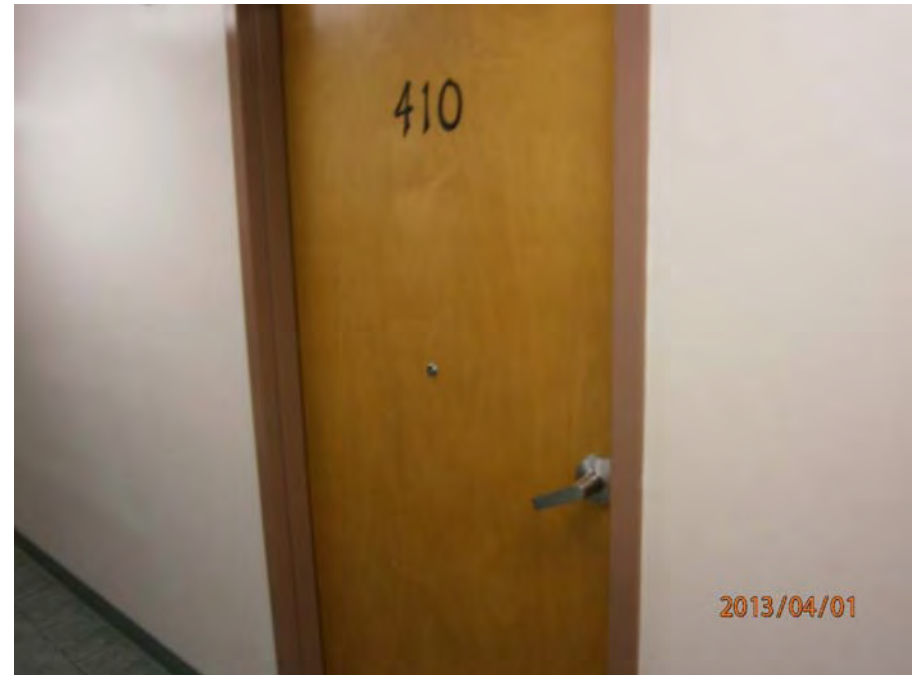
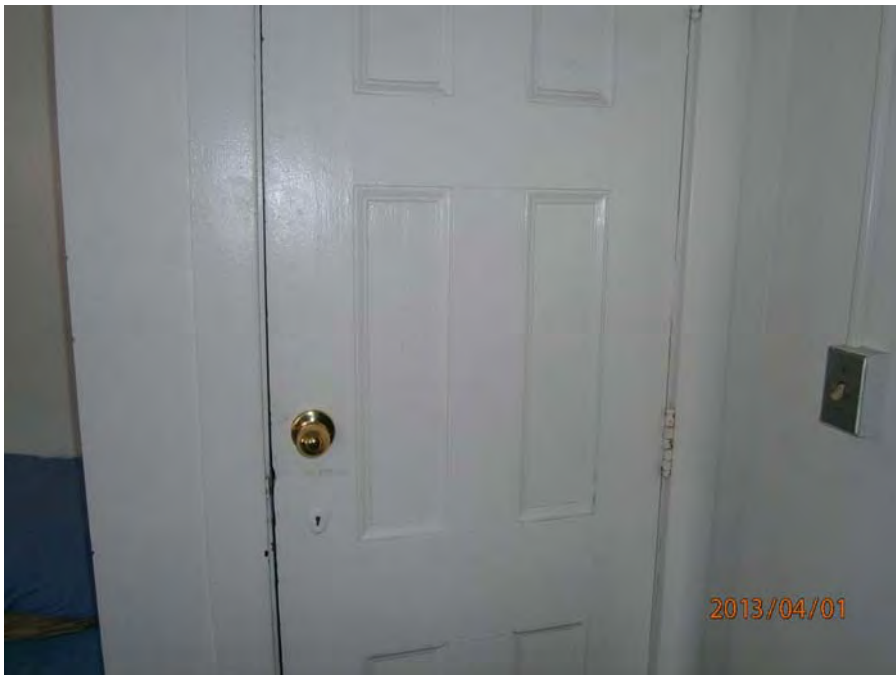
22. Typical unit hallway door

23. Typical unit interior door

- In-unit flooring replacement is shown beginning in Year 1 and throughout the plan. An allowance for unit hallway and interior door repairs and/or replacement is shown in every year of the plan.
